GREENVILLE POND DAM
PHASE I
INSPECTION / EVALUATION REPORT

Dam Name: Greenville Pond Dam
National ID No.: MA00982
Owner: Town of Leicester
Town: Leicester, MA
Consultant: Fuss & O'Neill, Inc.
Date of Inspection: June 30, 2021

EXECUTIVE SUMMARY

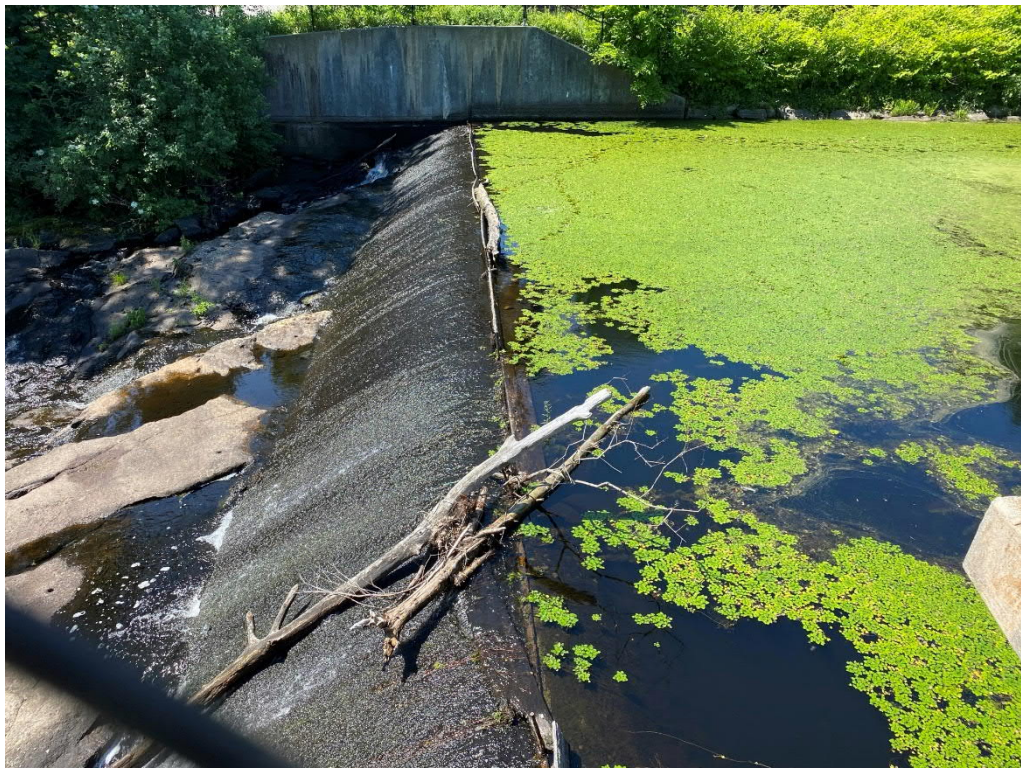
The spillway consists of a concrete ogee weir constructed on bedrock. There is minor concrete erosion on the downstream face of the weir. The 1-foot high flashboards were rotted and three were missing. Debris has collected against the flashboards. There were vertical cracks in each of the spillway training walls, though neither shows signs of displacement. The left training wall joint at the outlet discharge point is deteriorating. There are trees growing along the spillway discharge channel near the right training wall. The fencing along the right and left training wall was replaced and is in good condition. The discharge channel is predominantly bedrock. The left downstream channel is formed by a stone masonry wall that is in generally good condition.

Photo 12: Overview of weir – note debris, failing flashboards

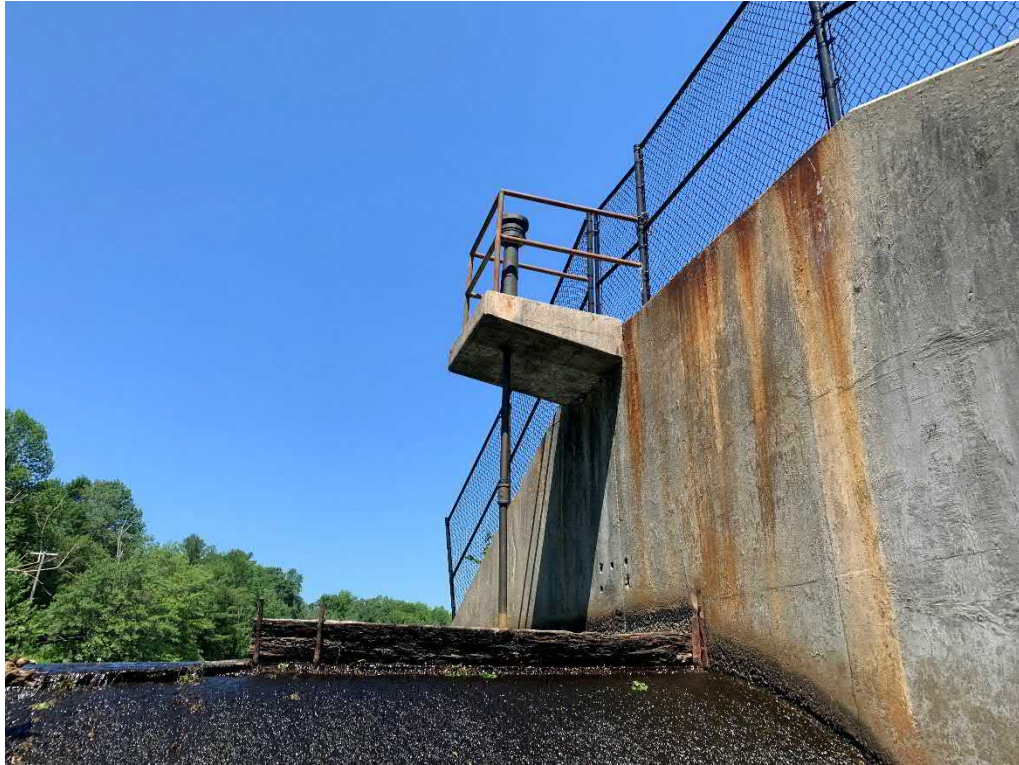
Photo 15: Overview of gatehouse exterior – note new chain link fence

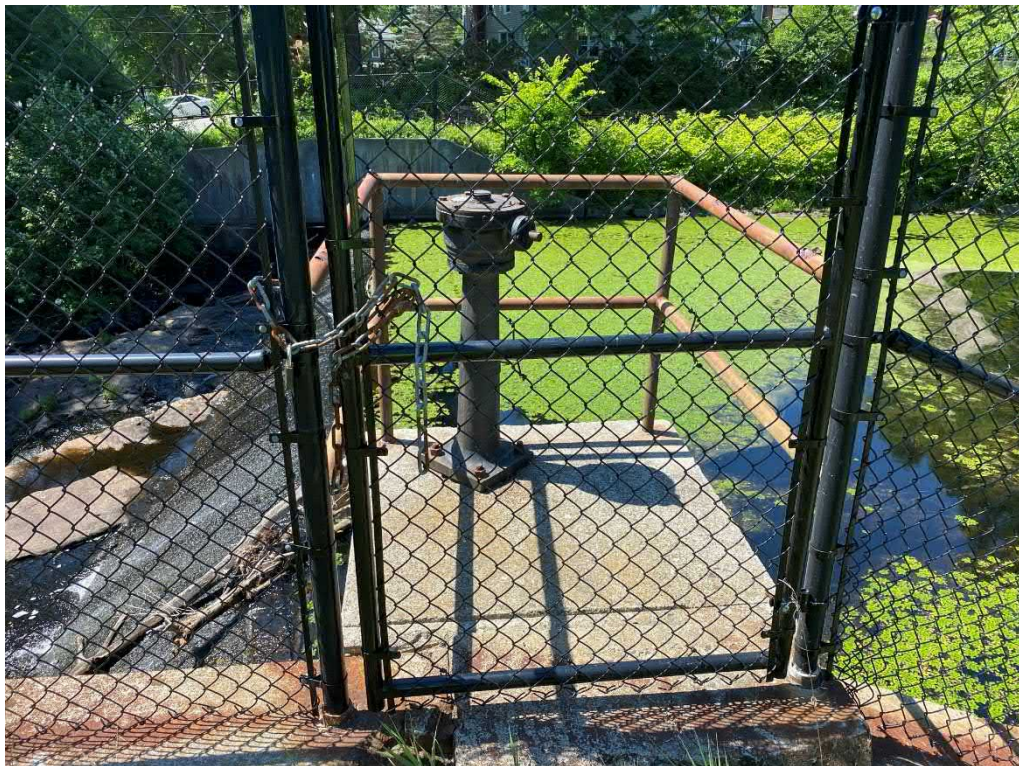
Photo 16: Overview of operator-note new fencing and locked gate

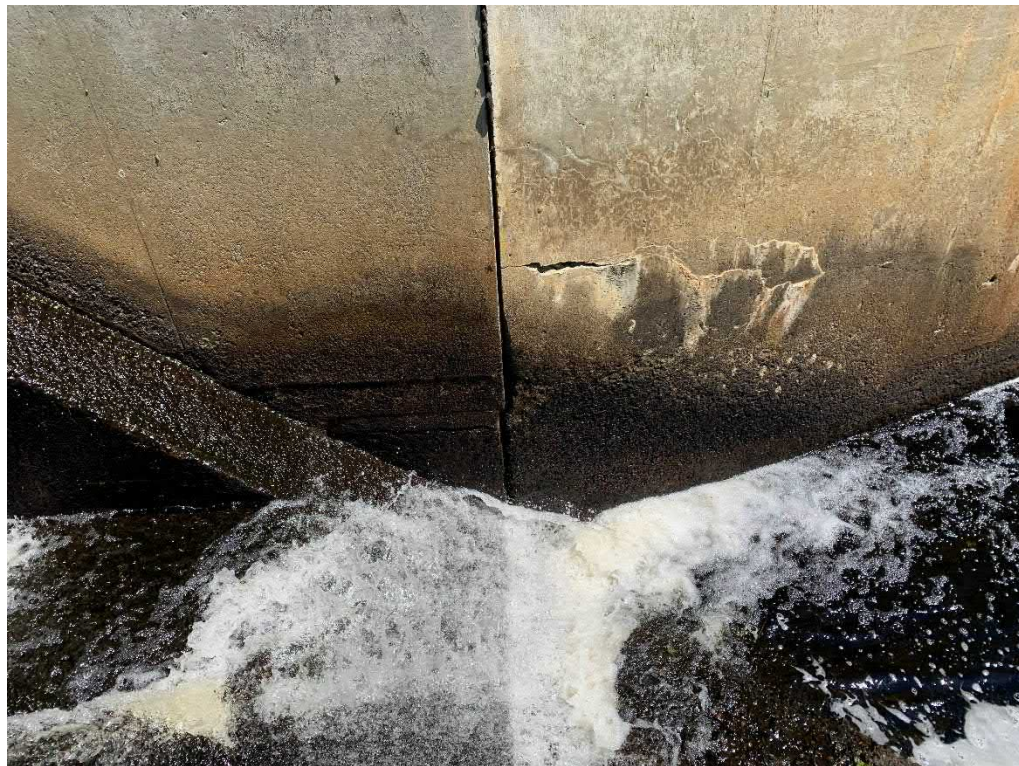
No design calculations were reviewed and no independent assessments were performed as part of this Phase I Inspection that would allow a formal structural stability analysis of the structure. Minor cracks were observed in each of the spillway training walls; however, there did not appear to be misalignment associated with these cracks. Based on the visual observations made during the inspection, the dam appears to be stable at the current time. Extreme care should be exercised when operating the gate valve due to the severe cracking observed at the platform/wall joint.

Photo 20: Crack and deteriorating joint left training wall

- Remove all trees and woody vegetation from within 15 feet of the right spillway training wall.
- Repair cracked concrete in the spillway training walls.

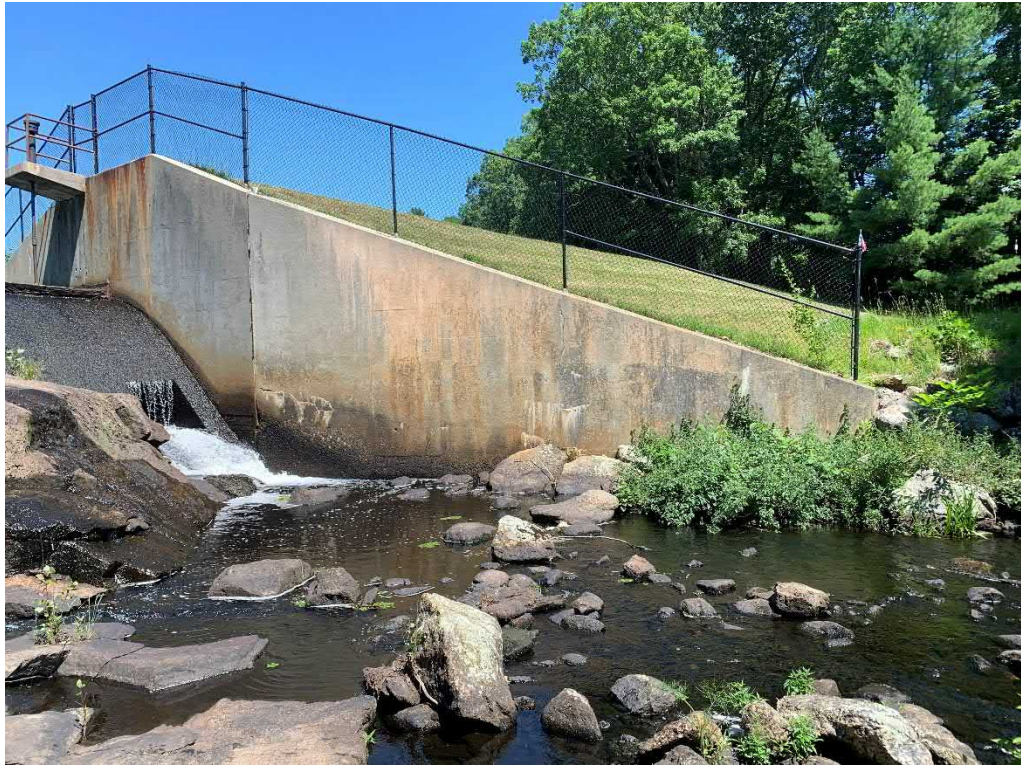
Photo 21: Cracks in left training wall

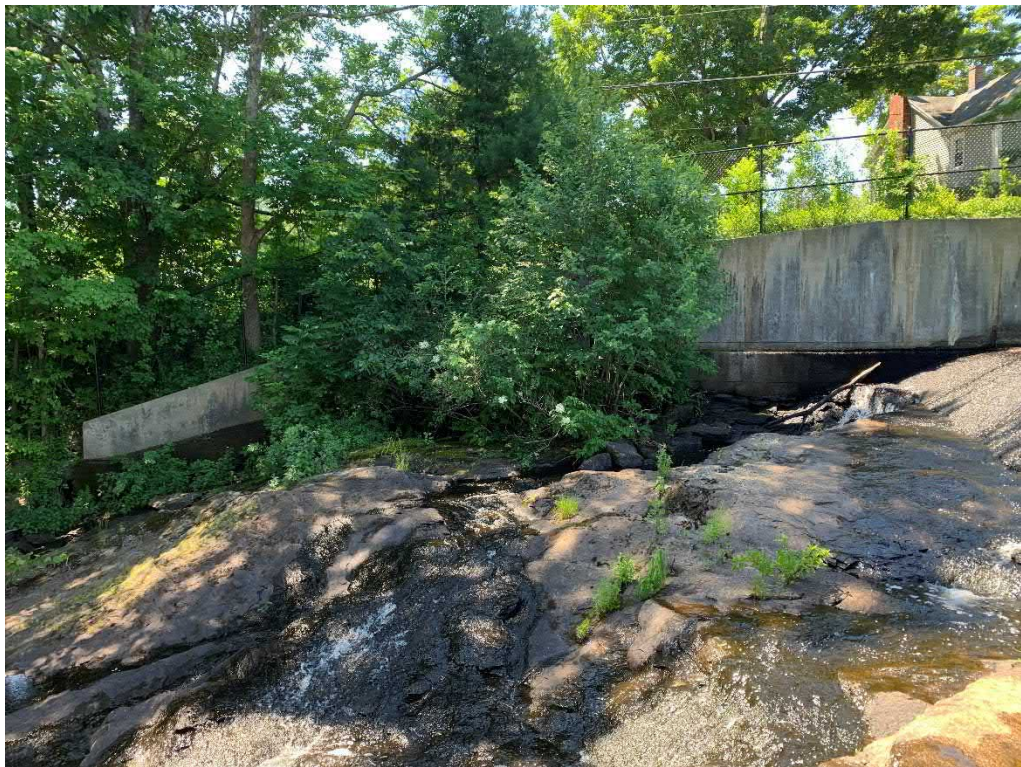
Photo 22: Vegetation growing in spillway channel near right abutment

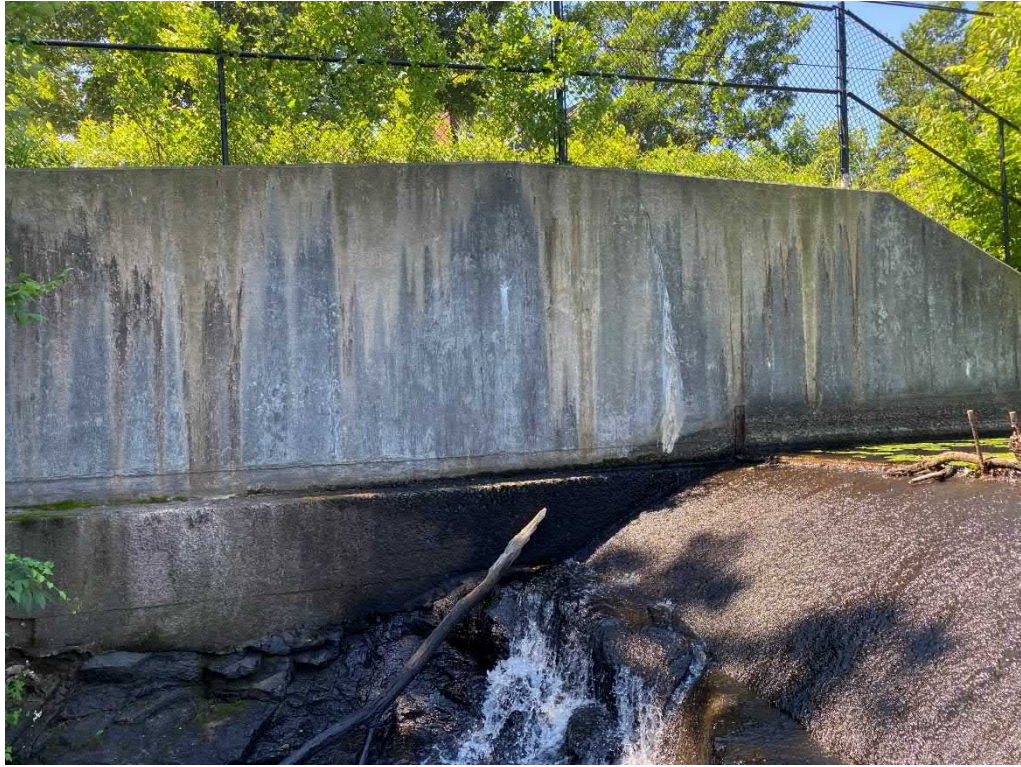
Photo 23: Cracks in right training wall

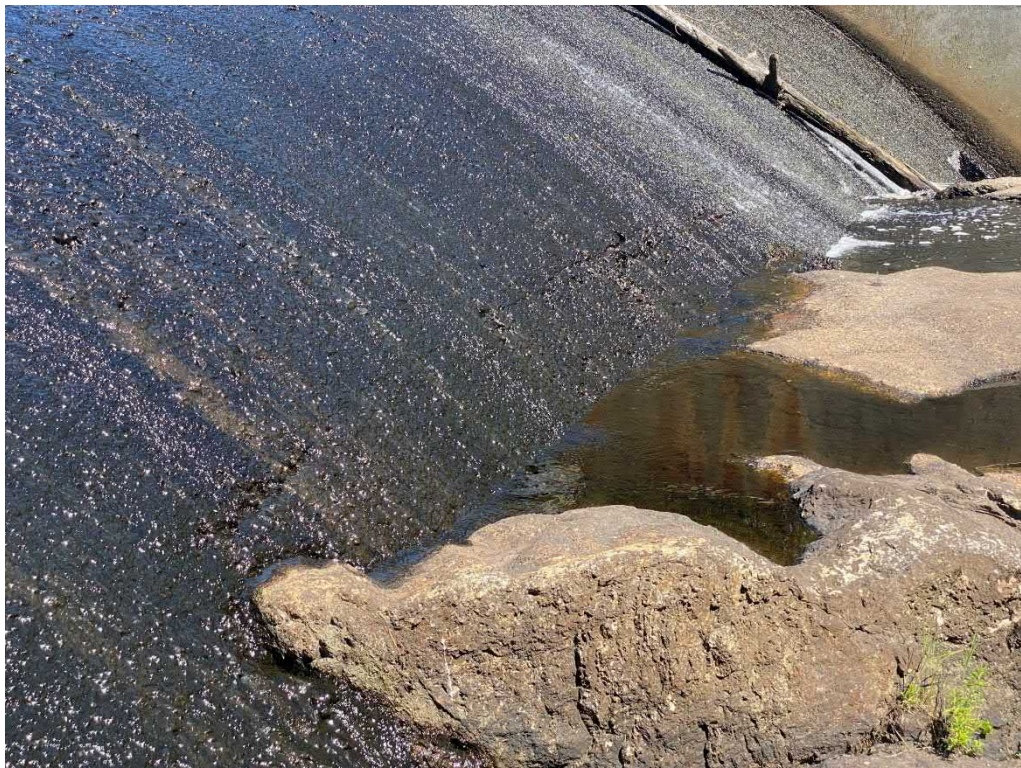
Photo 24: Concrete erosion in ogee weir face

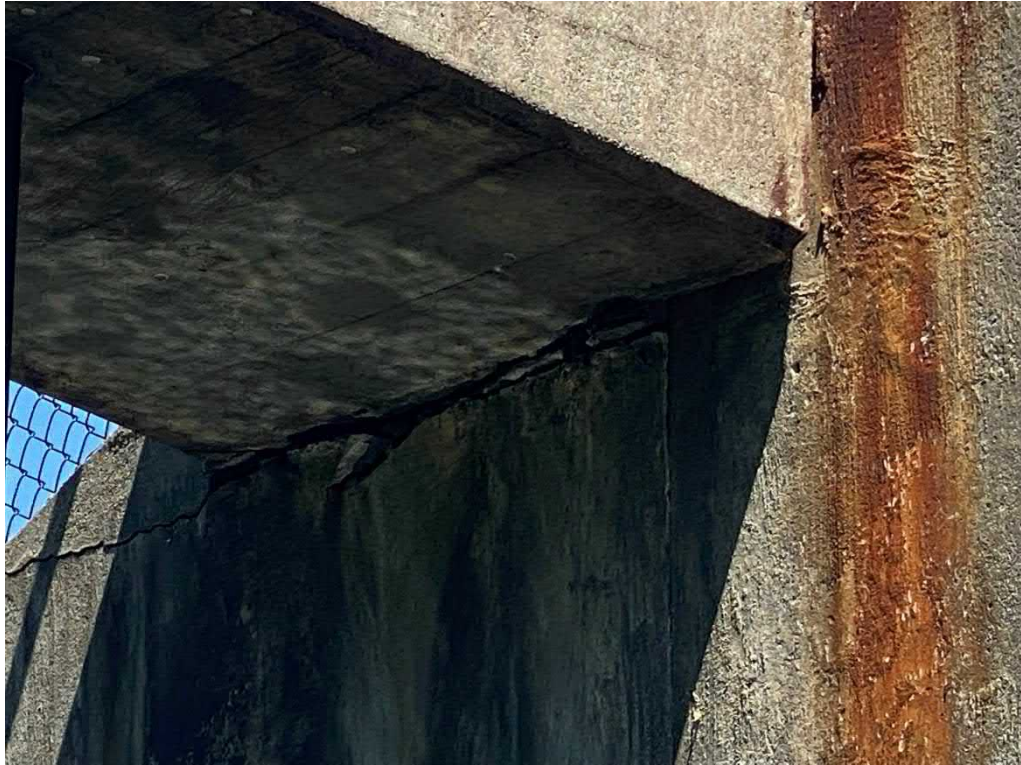
Photo 25: Cracked concrete in cantilevered gate operator pedestal and training wall

ADDITIONAL COMMENTS: Concrete platform of operator has significant cracking at abutment with left training wall

- Repair structural deficiencies with the cantilevered low-level outlet platform.
- Remove encroaching trees and brush at the left abutment on the upstream face.

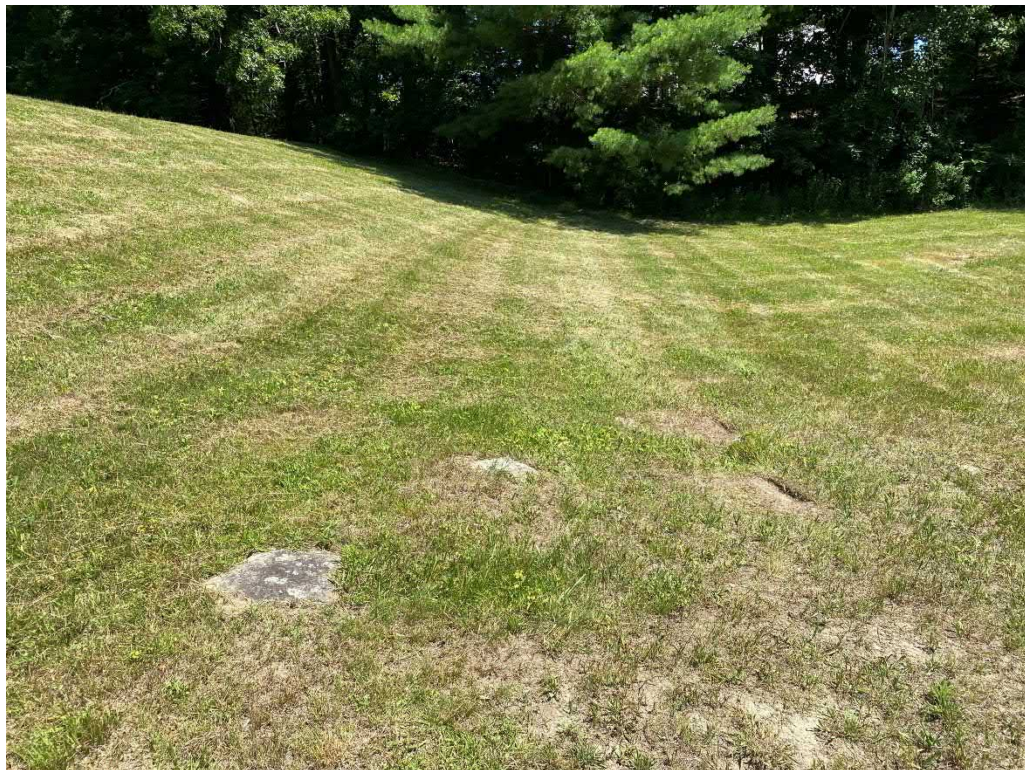
Photo 26: Previous sloughed area on downstream embankment – now vegetated and stable

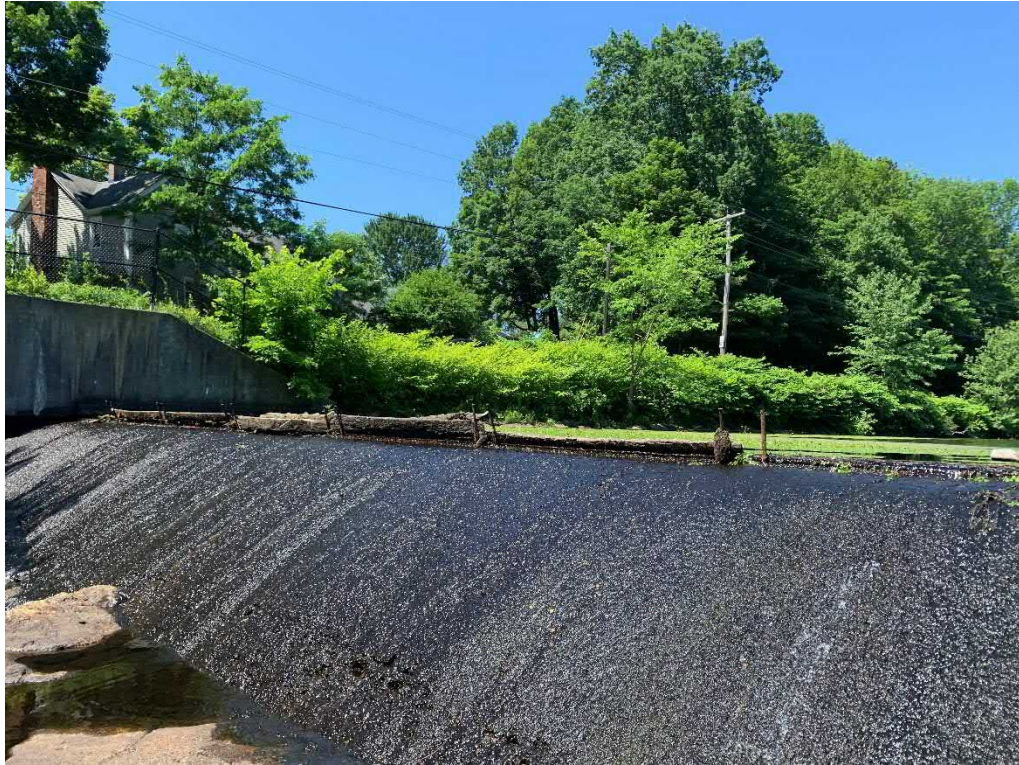
Photo 27: Overview of spillway flashboards (note missing boards)

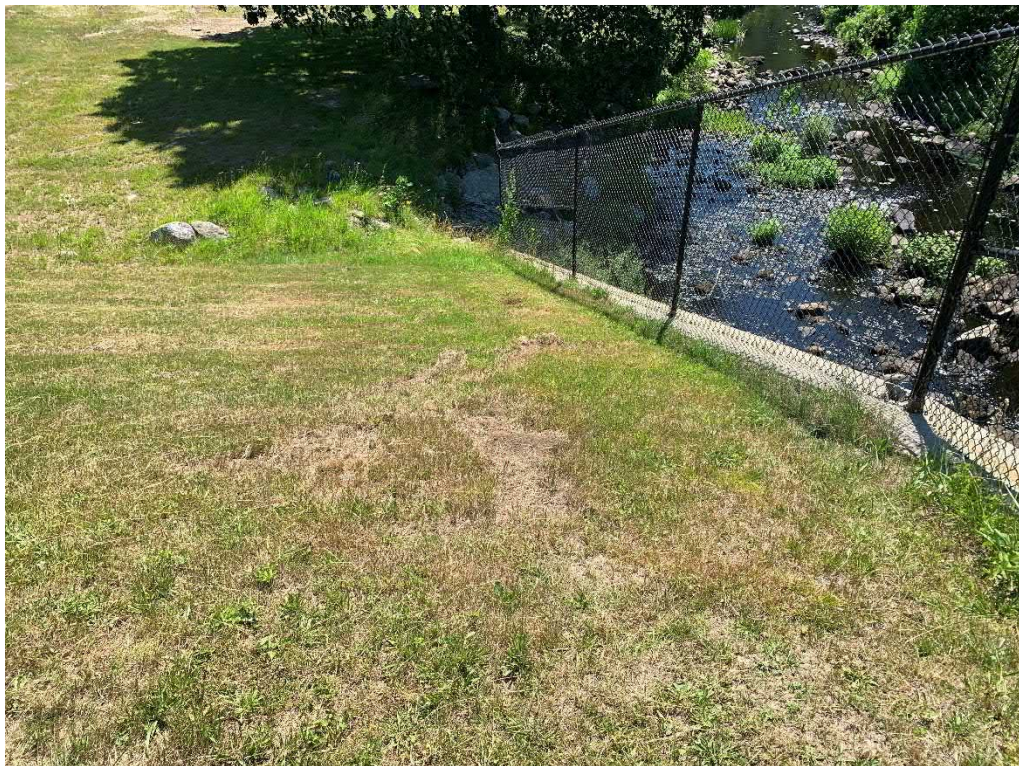
The downstream face of the dam left of the spillway is grass-covered and well kept. Small trees and brush have grown between River Street and the right spillway training wall along the downstream face of the dam. Two minor animal burrows were observed at the toe of the downstream face. Minor sloughing, erosion and bare areas were observed adjacent to the left training wall.

Photo 28: Minor erosion and bare spots on downstream slope

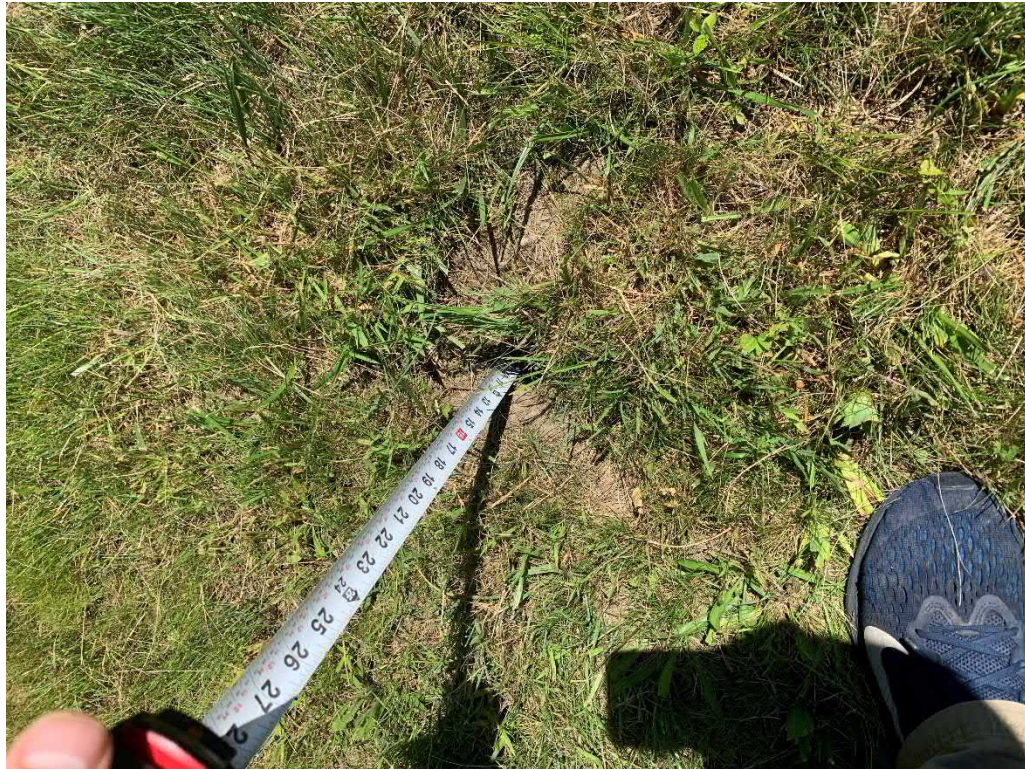
Photo 29: Animal burrow #1 on the downstream slope (area of specific deficiencies)

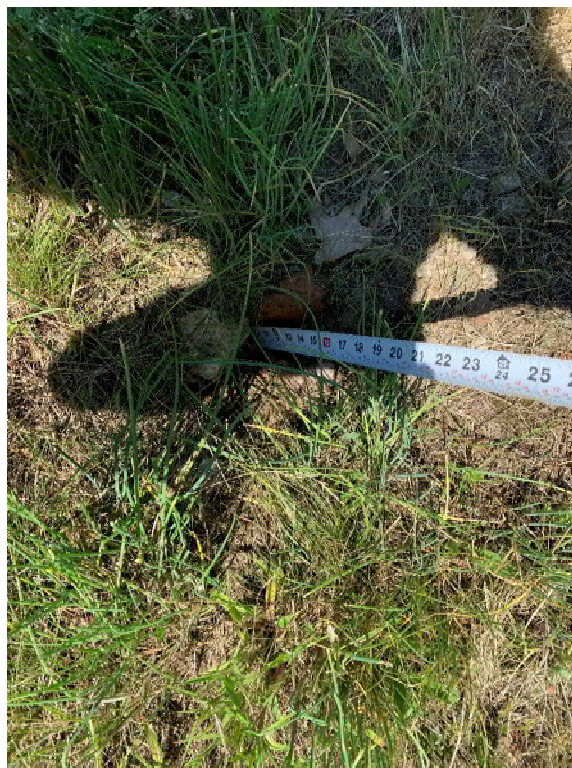
Photo 30: Animal burrow #2 on the downstream slope (area of specific deficiencies)
