**--WAITE POND DAM--**  
**PHASE I**  
INSPECTION / EVALUATION REPORT

Dam Name: **Waite Pond Dam**

State Dam ID#: **3-14-151-21**

Date of Inspection: **August 8, 2012**

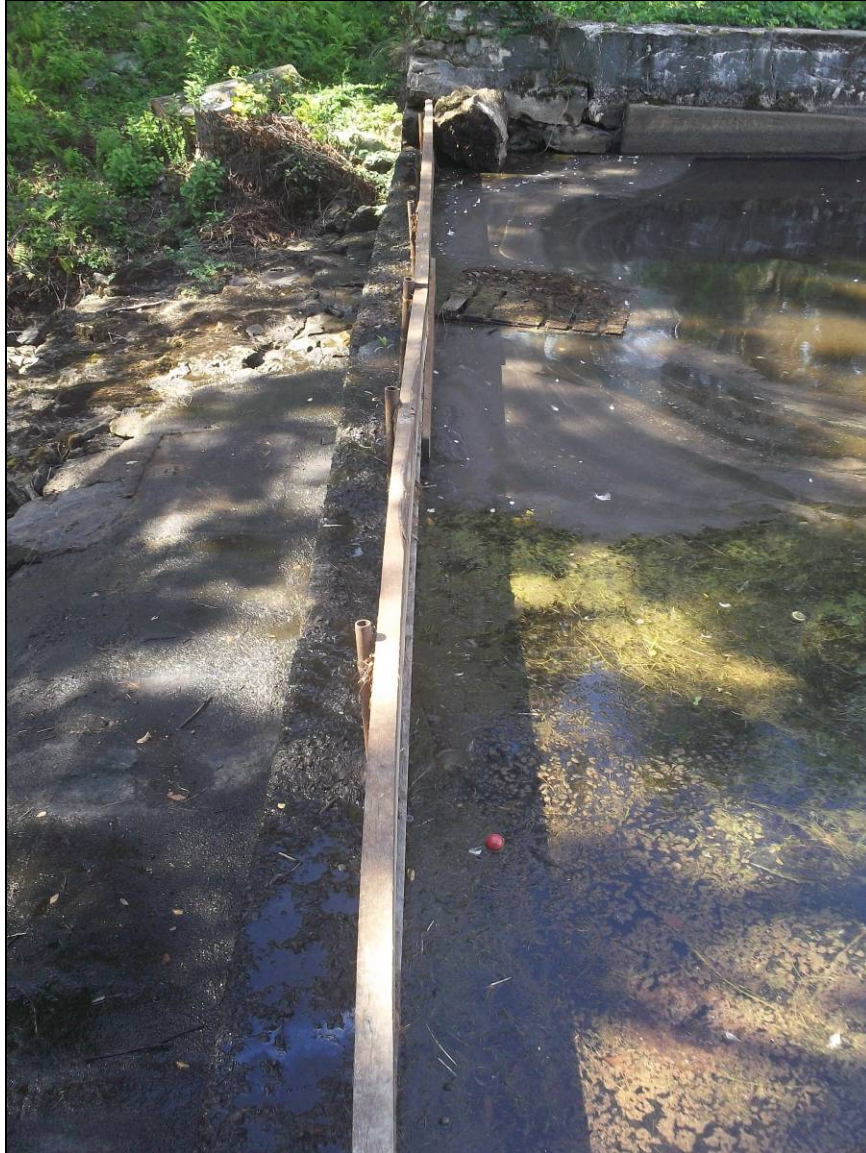
is breaking into fragments but seems to be functioning satisfactorily. (See Photo 14) Weir boards were in place during our inspection and appeared to be in satisfactory condition, with minor leakage through the boards. (See Photo 13)

Photo 13: Overview of weir

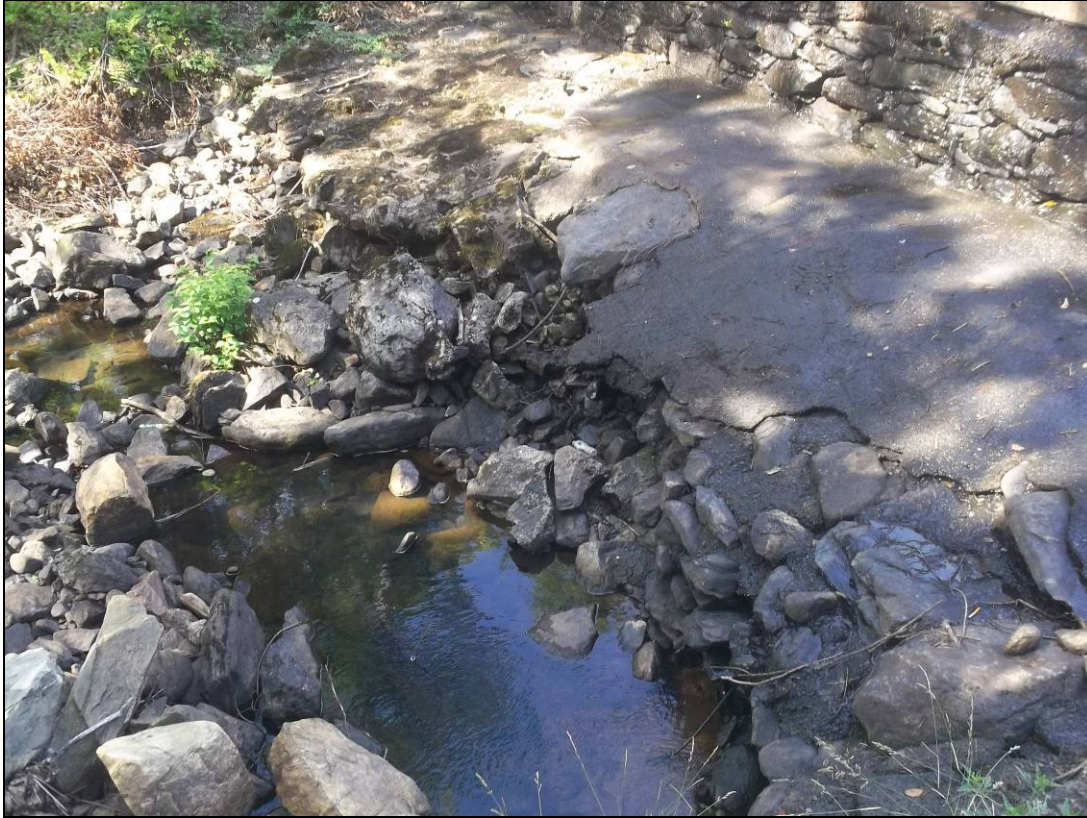
The spillway consists of a concrete slab with 2 feet of wooden weir boards. The side walls of the spillway are cracked and eroded. The stilling basin consists of stone rubble covered with concrete that spills overflow to the channel below. The concrete

Photo 14: Overview of stilling basin

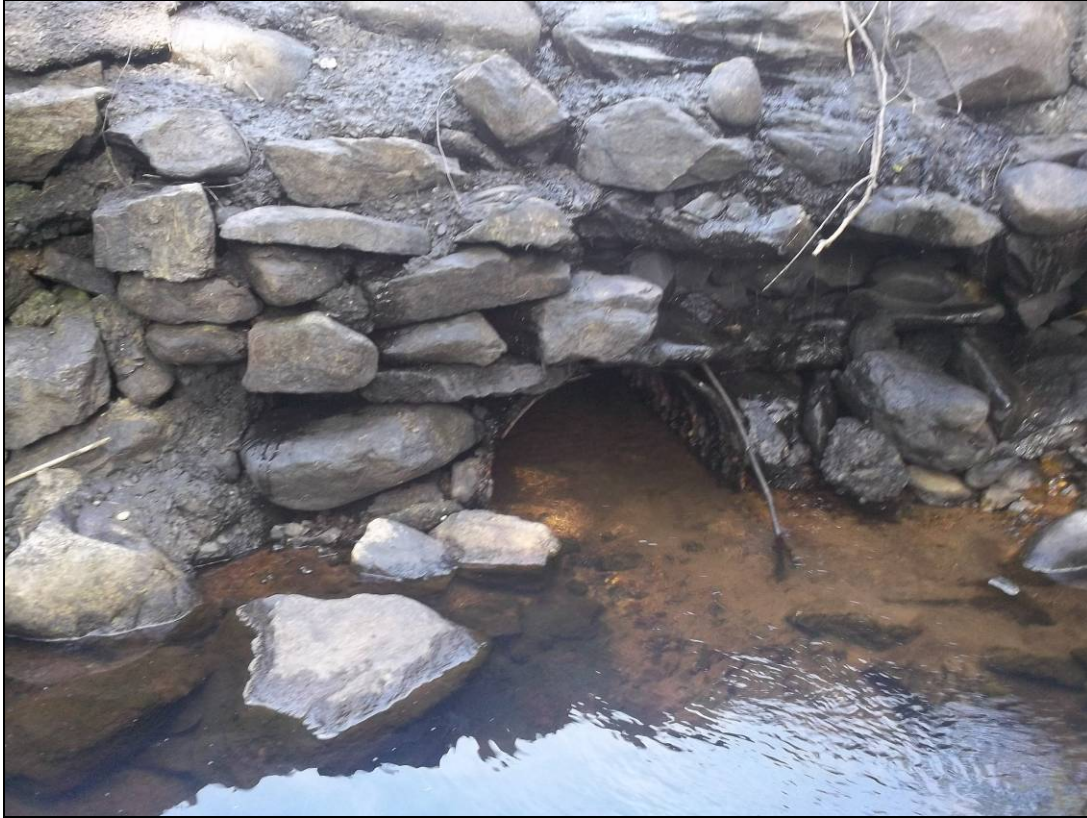
The 24-inch CMP low level outlet was rusted and appeared to be approximately 1/2 full of sediment, but was flowing (See Photo 18). The operator is located in a circular structure in the impoundment. There is currently no access to the structure except by wading or boat. There is no roof on the structure, which is leaning over (See Photo 16). The concrete foundation is severely eroded. It is not known if the gate operator is functional.

Photo 18: Low level outlet – 24” CMP

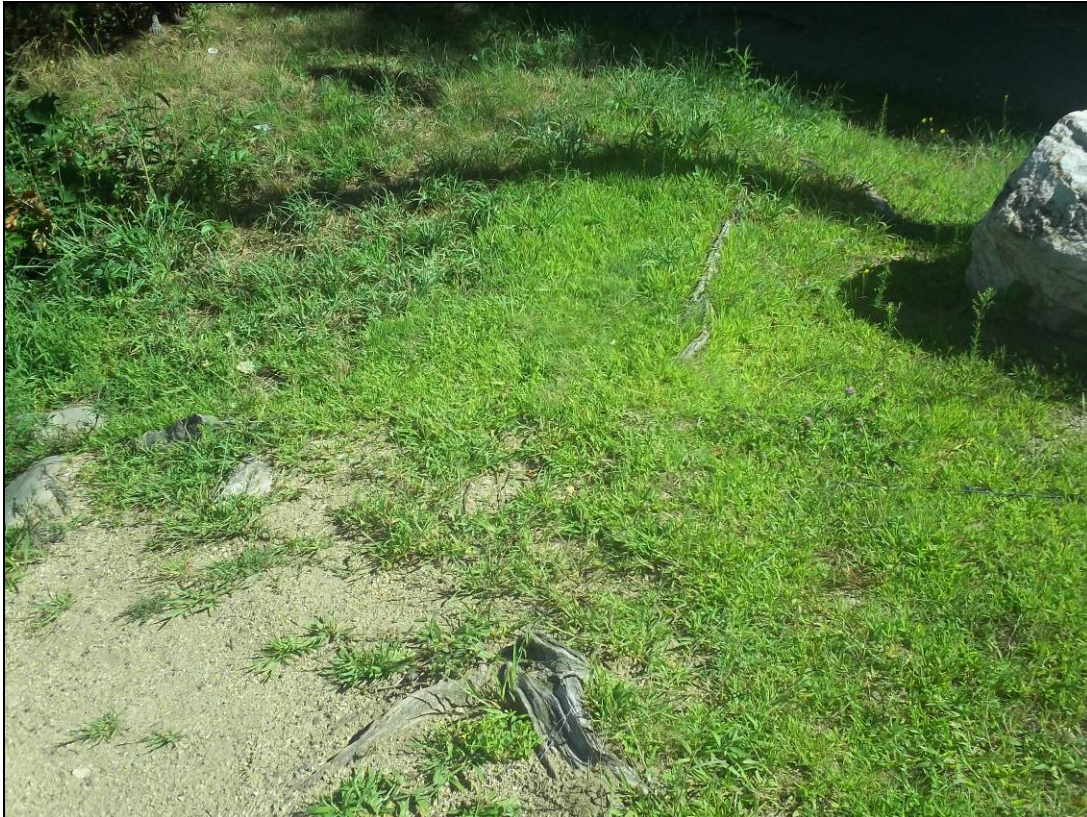
- **Crest** The crest of the dam consists of vegetated earth. Depressions were observed on the right crest. Sparse vegetation and tree root encroachment were observed on the left crest. (See Photo 20 )

Photo 20: Areas of specific deficiencies-tree roots, sparse vegetative cover

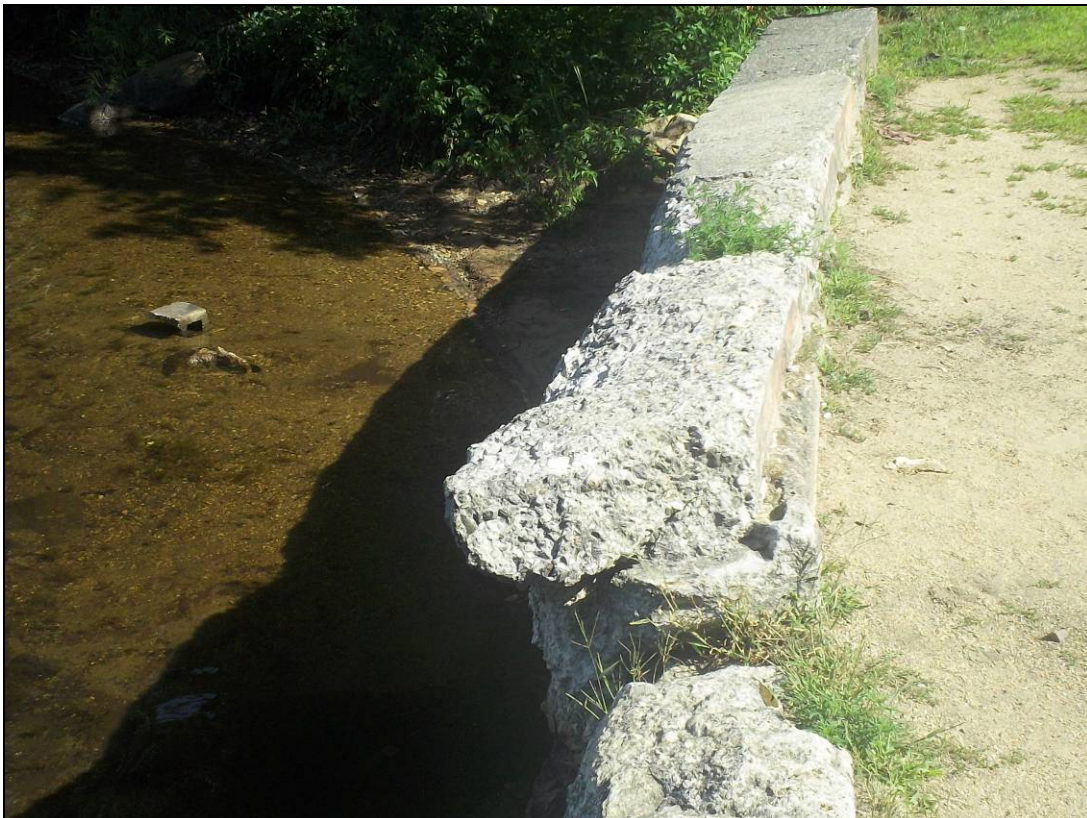
- **Abutments** Abutments to the dam appeared to be in good condition and in good contact with the earthen and stone portions of the dam.
- **Upstream Face** Severe erosion, cracking and undermining of the concrete covered masonry walls were observed. (See Photos 21 and 23)

Photo 21: Areas of specific deficiencies-deteriorating concrete, leaning wall

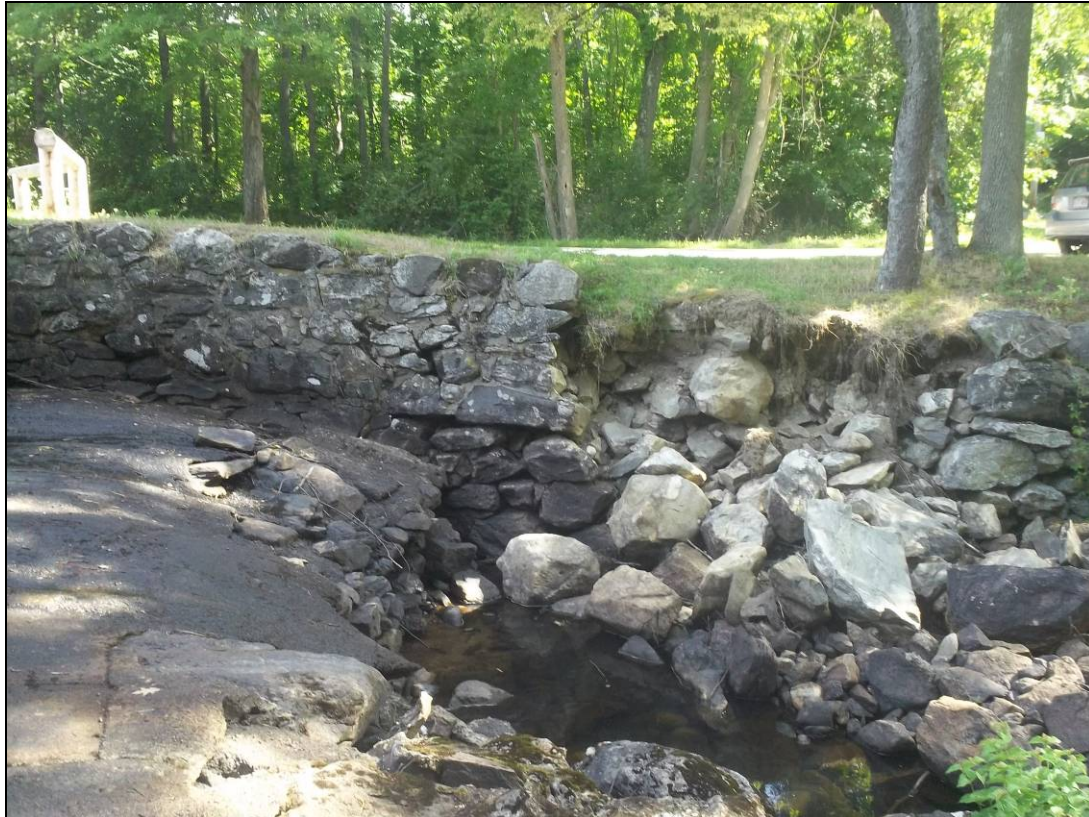
- **Downstream Face** The right downstream face consists of vertical dry-laid stone masonry wall. The wall appeared to be slightly overhanging and some stones appeared to be missing. The left downstream area consists of a gravel parking area supported by a vertical masonry wall parallel to the brook channel. The wall has partially collapsed. (See Photo 22)

Photo 22: Areas of specific deficiencies-collapsed masonry wall

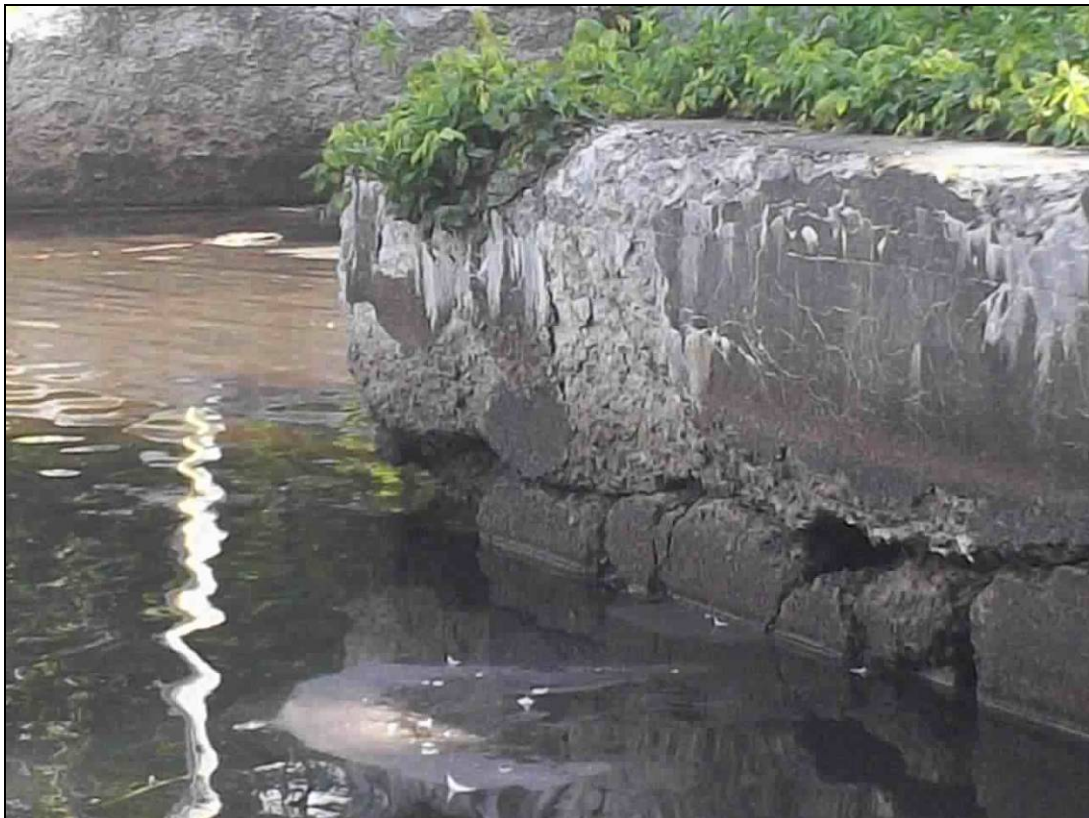
Photo 23: Areas of specific deficiencies-undermined cracked wall
