RE: Follow-up Inspection
Waite Pond Dam MA00987
Leicester, MA

Waite Pond Dam Follow-Up Inspection
July 29, 2016

Commonwealth of Massachusetts
Department of Conservation and Recreation
Office of Dam Safety Poor Condition Dam
Follow-up Inspection Form

Dam Name: Waite Pond Dam
Dam Owner: Town of Leicester
Nat. ID Number: MA00987
Hazard Potential: Significant
Location of Dam (town): Leicester
Coordinate location (lat, long): 42° 14.9' N, 71° 53.3' W
Date of Inspection: July 21, 2016
Weather: Clear, 75 degrees F

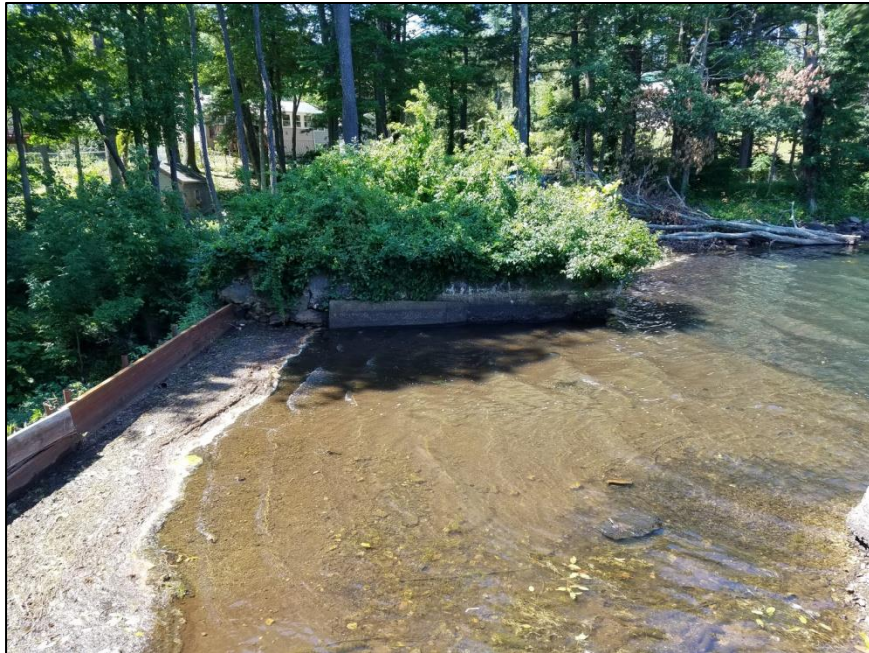
Photo 11: Overview of right training wall

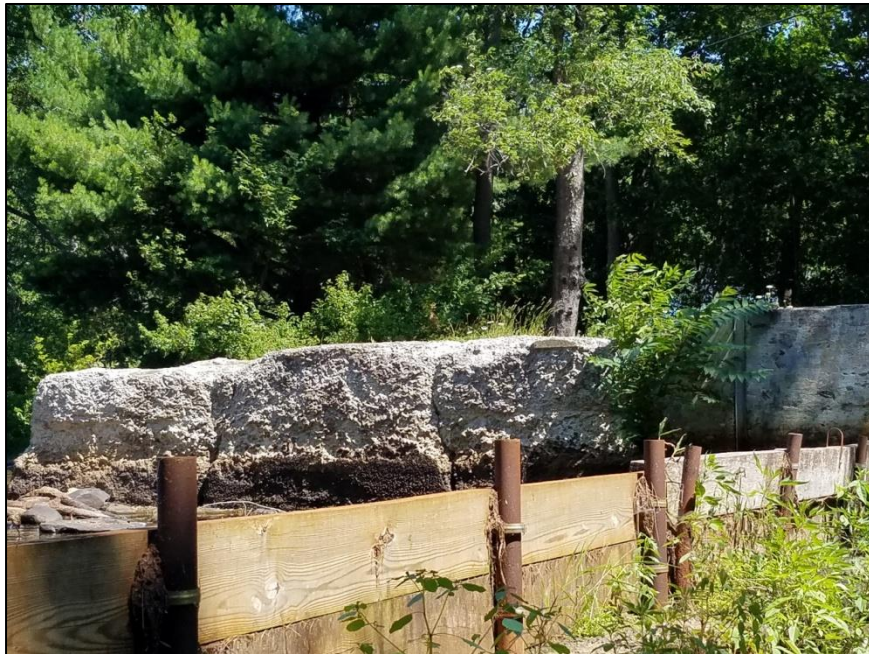
Photo 12: Overview of left training wall

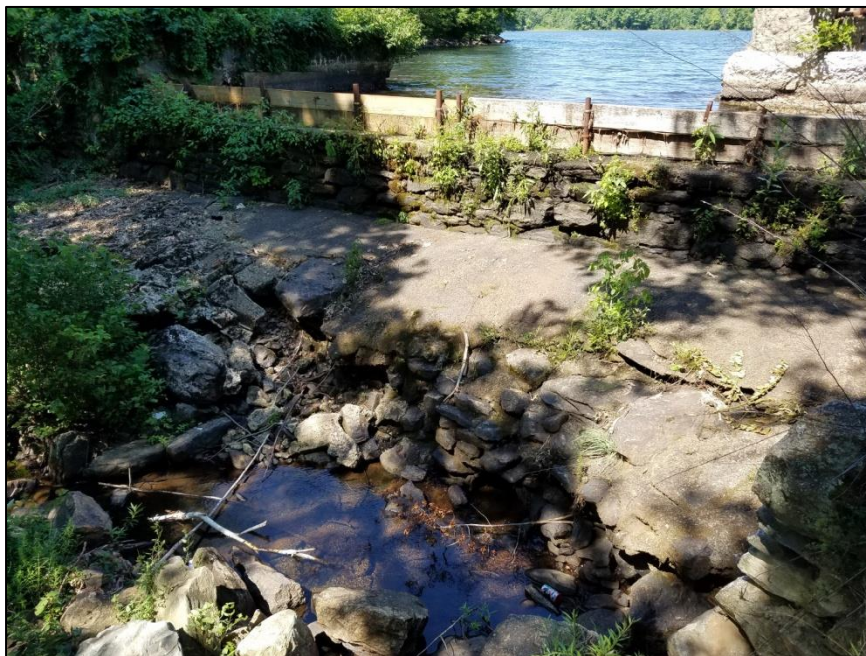
- Overall Condition of Dam at the Time of the Current Follow-up Inspection:
The current condition of the dam is Poor. In addition to the previous inspection deficiencies listed above, seepage was observed through the energy dissipation basin and around the low level outlet pipe into the downstream channel. Animal burrows were observed in the vicinity of the left downstream stone retaining wall and crest.

Photo 14: Overview of stilling basin

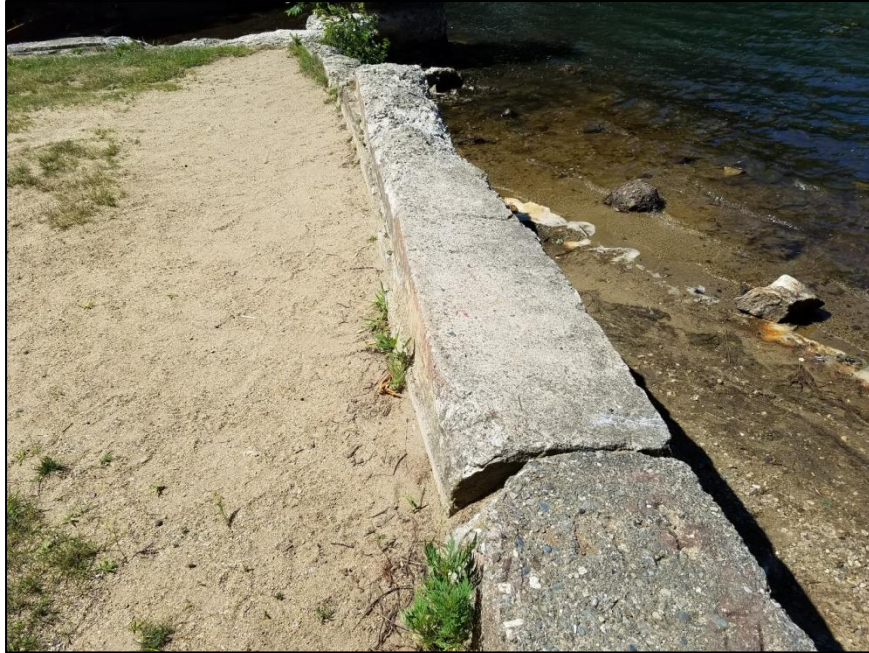
Photo 17: Leaning upstream wall

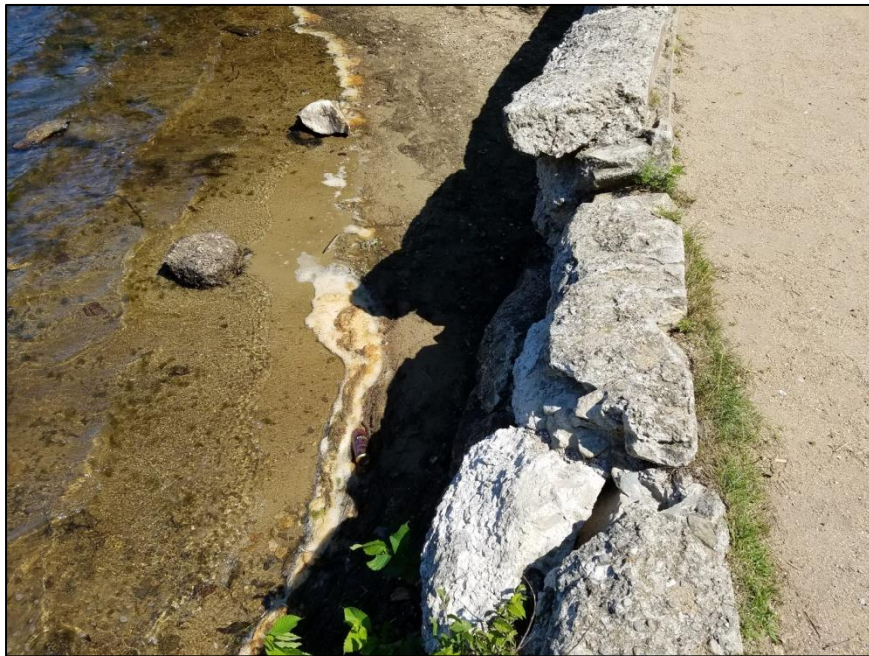
Photo 18: Deteriorating upstream wall

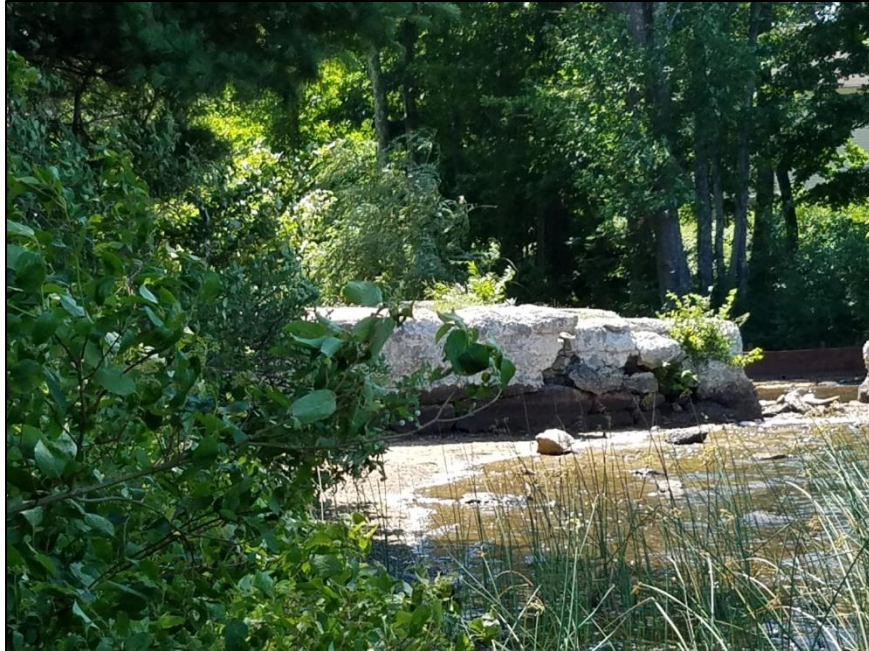
Photo 19: Deteriorating upstream wall

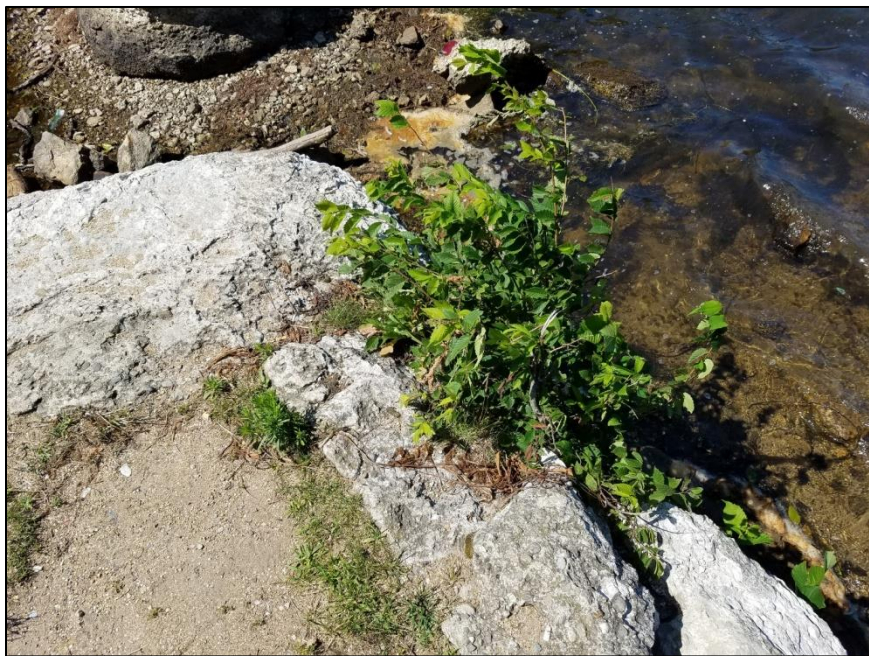
Photo 20: Woody vegetation growing through upstream wall

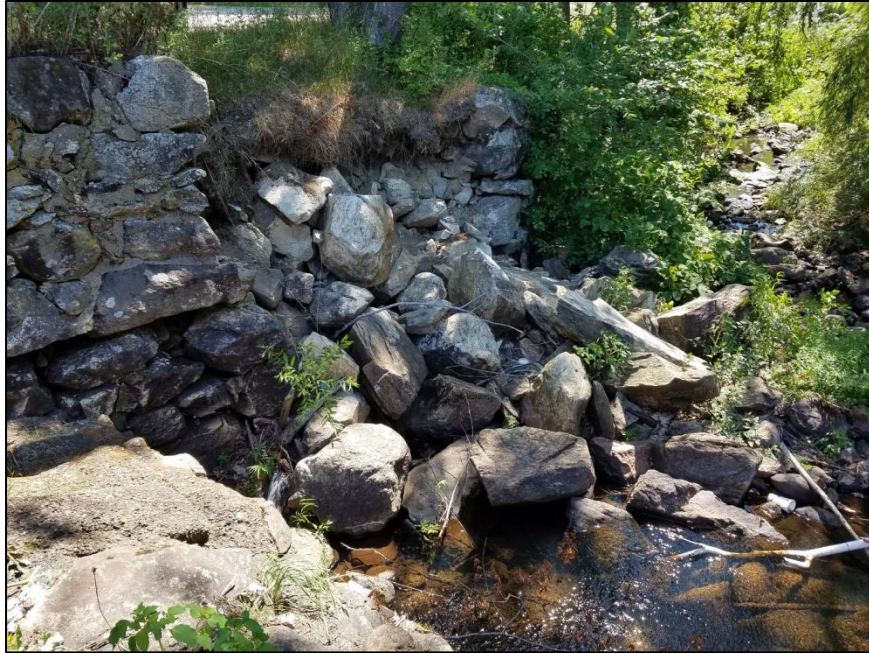
Photo 21: Collapsed downstream training wall

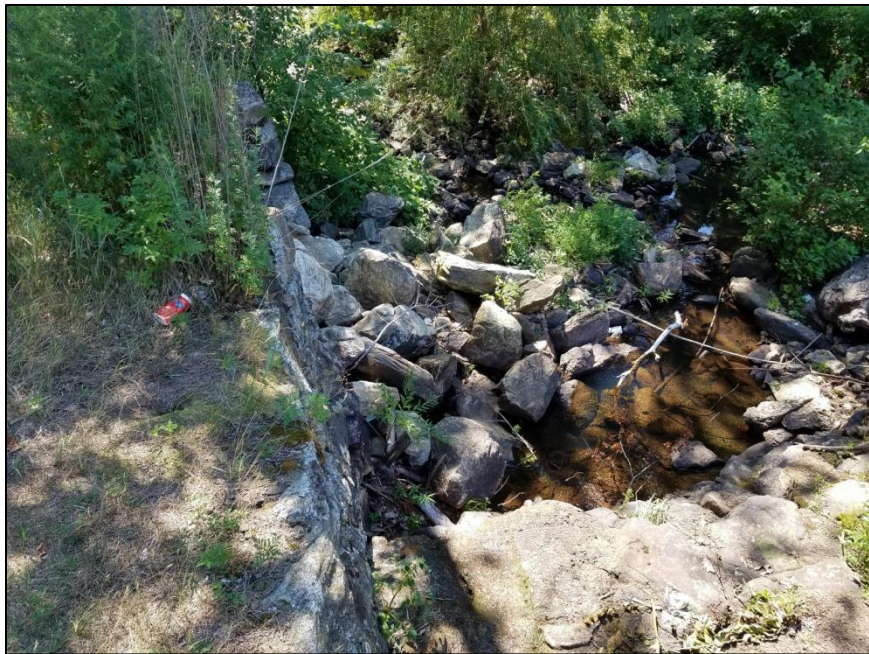
Photo 22: Collapsed downstream training wall

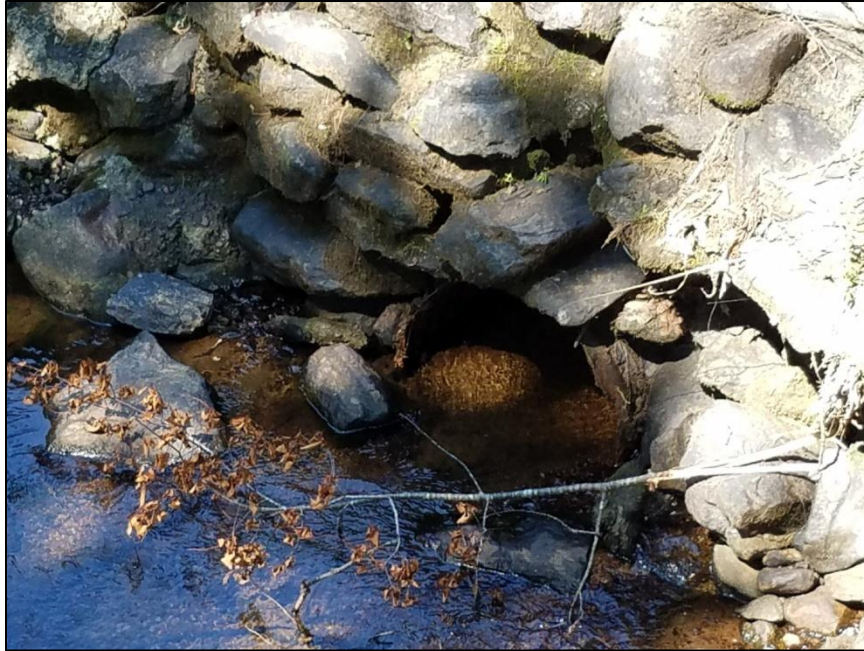
Photo 23: Low-level outlet pipe

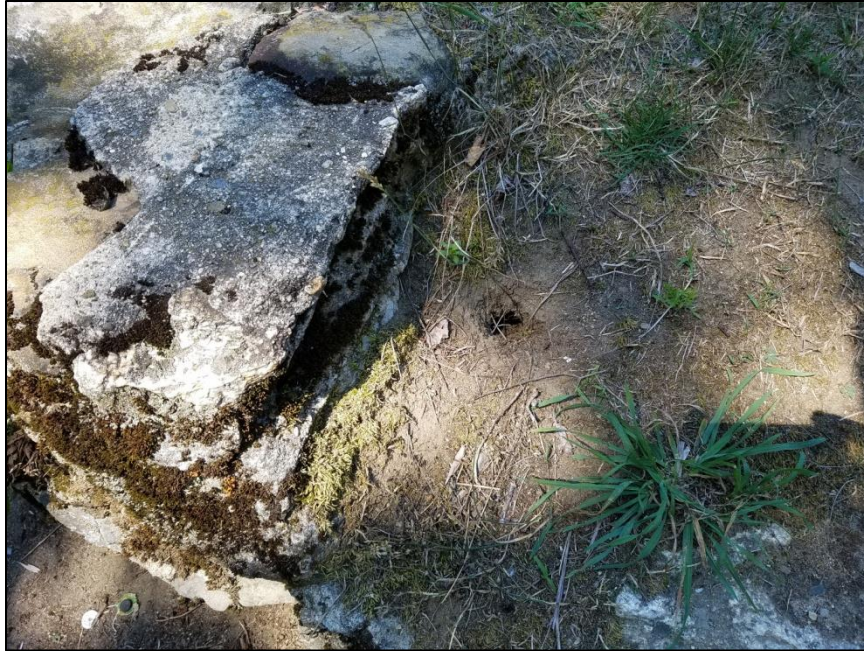
Photo 25: Burrows observed in downstream left stone retaining wall

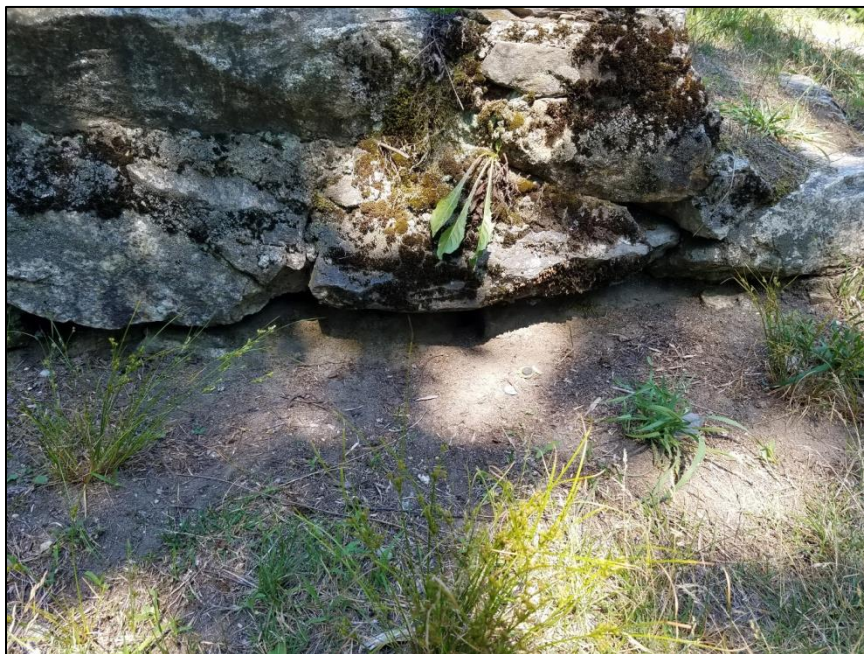
Photo 26: Burrows observed in downstream left stone retaining wall
