# **-- CEDAR MEADOW POND DAM --**

### **INSPECTION / EVALUATION REPORT**

NID ID#: MA00984

Date of Inspection: 5/28/20

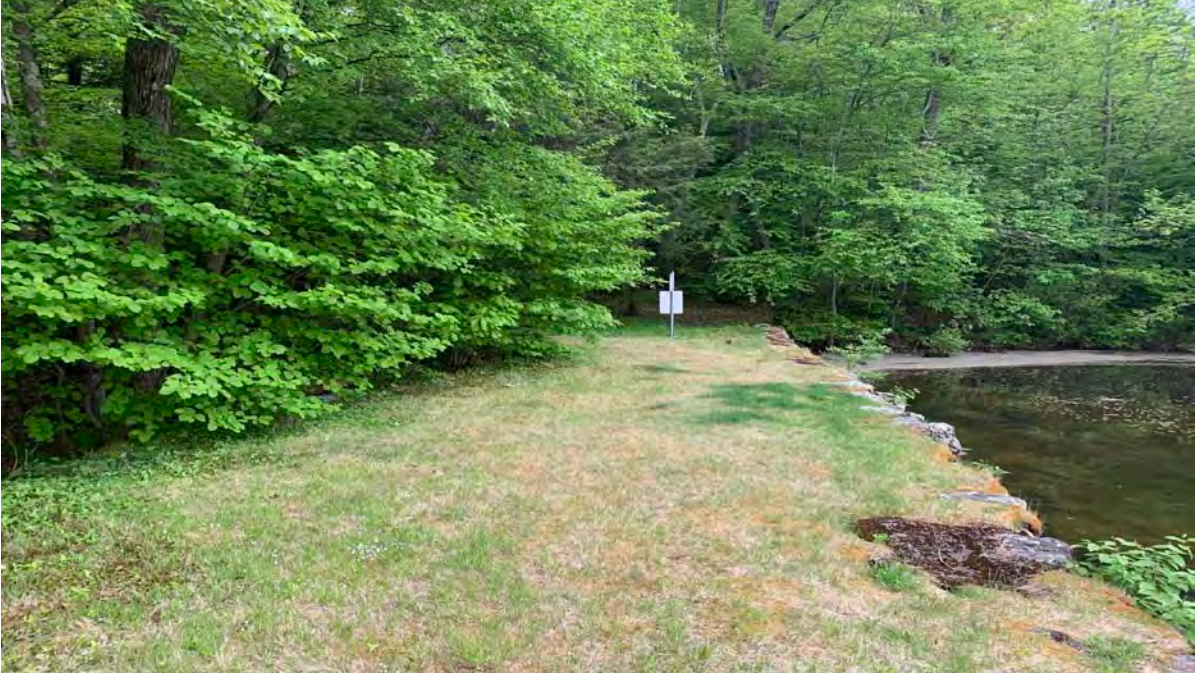
Photo 1: Right abutment from dam crest – Vegetation within 20 feet of the contact mainly on the upstream and downstream sides.

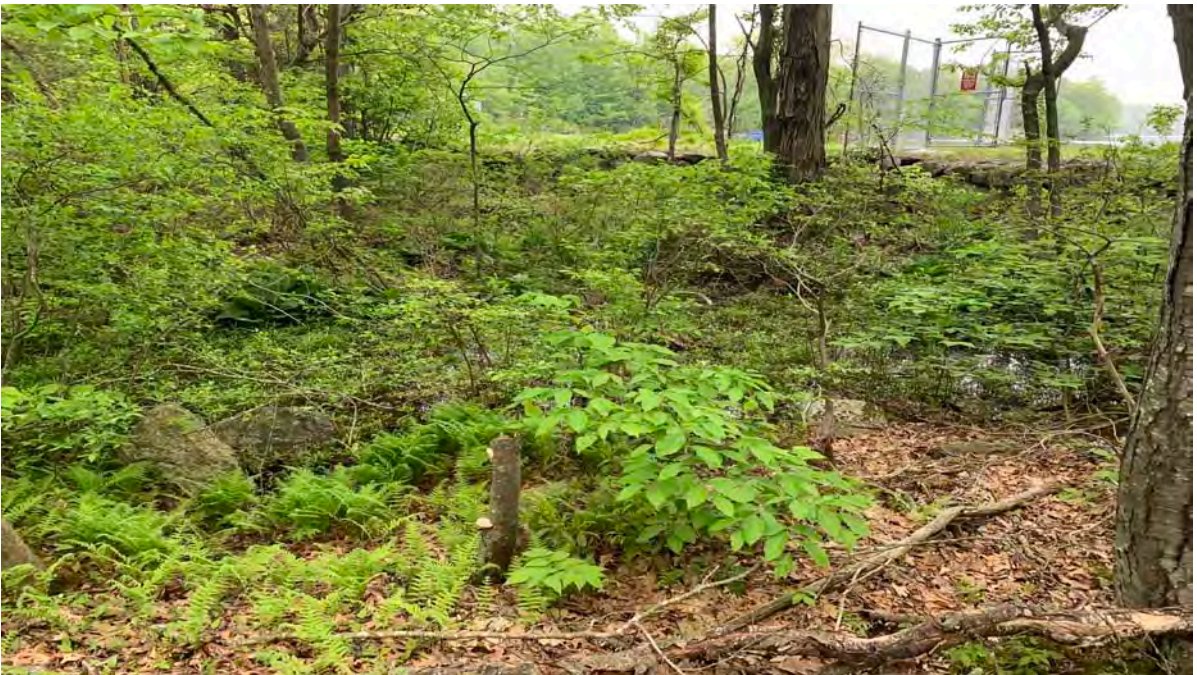
Several wet areas below the dam were observed. At the left end of the dam an area of ponding was observed beginning at the left abutment. Water was flowing minimally in this area toward the spillway discharge channel. The source of the water is not known at this time.

Photo 2: Downstream area at the left abutment – The area is wet with some pooled areas and minimal flow toward the spillway. Photo was taken from Charles Street.

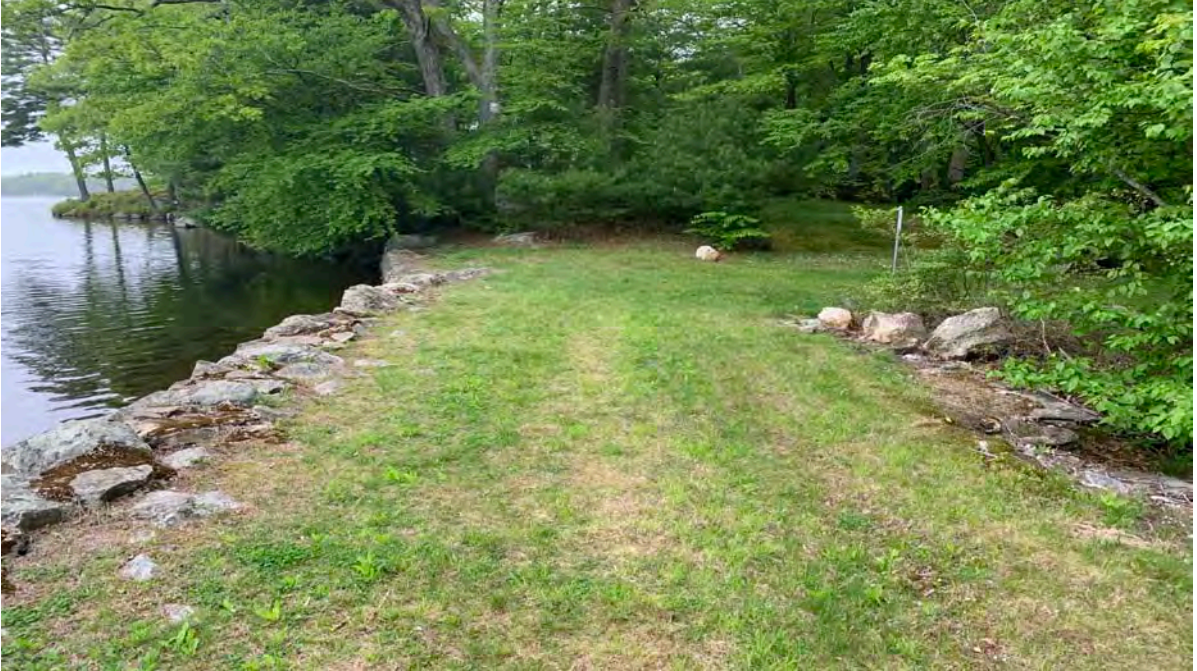
Photo 3: Left abutment from the crest – Minor thin areas of vegetation and shallow tire rutting.

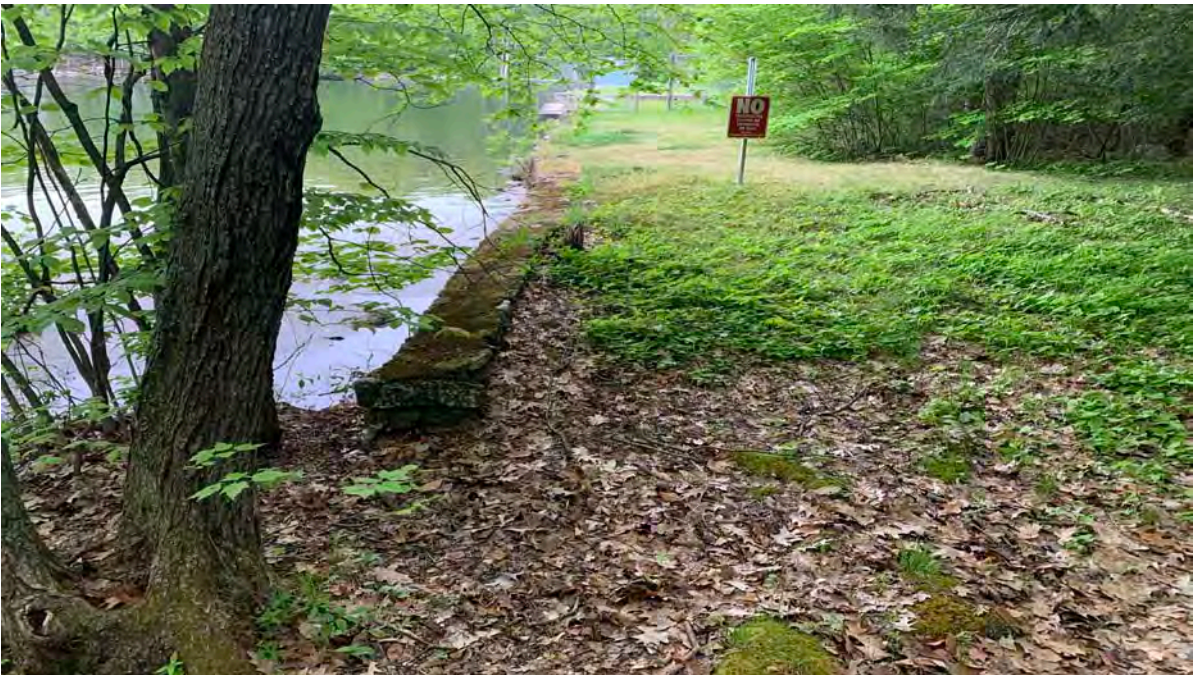
The masonry wall on the upstream face of the dam at the right abutment was observed to be tilted slightly toward the impoundment. This deficiency is minor and likely has little effect on the structural integrity of the dam. Many small voids/animal burrows were observed on the upstream side. No unusual movement was observed due to these voids however these areas should be monitored for any movement of the wall and/or movement within the crest area.

Photo 4: Right upstream face of the dam looking toward the spillway – The upstream wall was leaning outward.

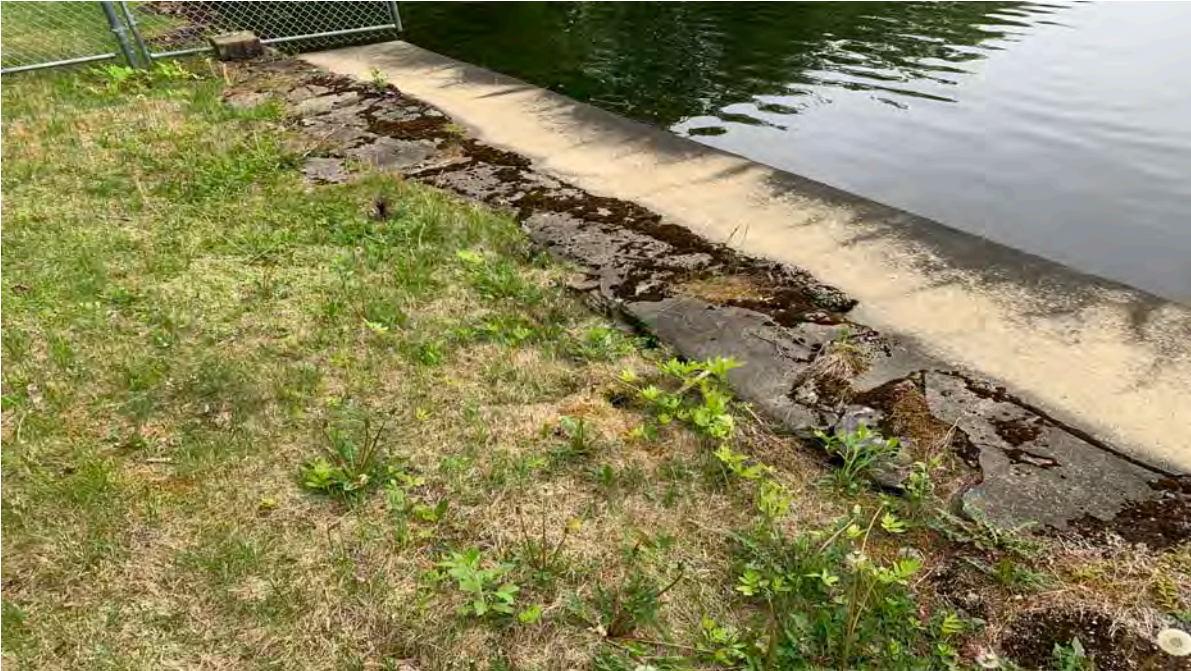
A section of masonry wall at the right abutment was tilted outward towards the impoundment. Animal burrows/small voids were observed behind the upstream masonry walls primarily to the right of the spillway. Very few voids were observed behind the wall along the left side of the dam.

Photo 5: Upstream face between the spillway and the fence on the right crest – Multiple small voids/animal burrows were observed in this area.

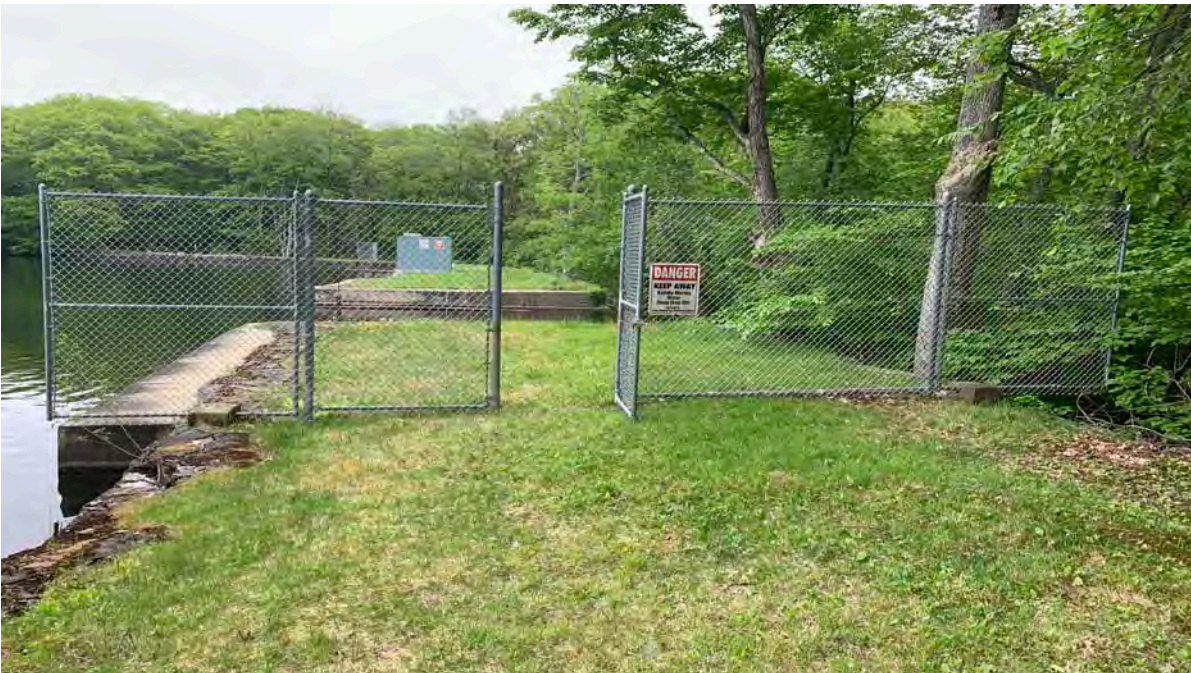
Photo 6: Right crest from the right abutment – There was some thin vegetation along the crest. Note the gate located across the crest.

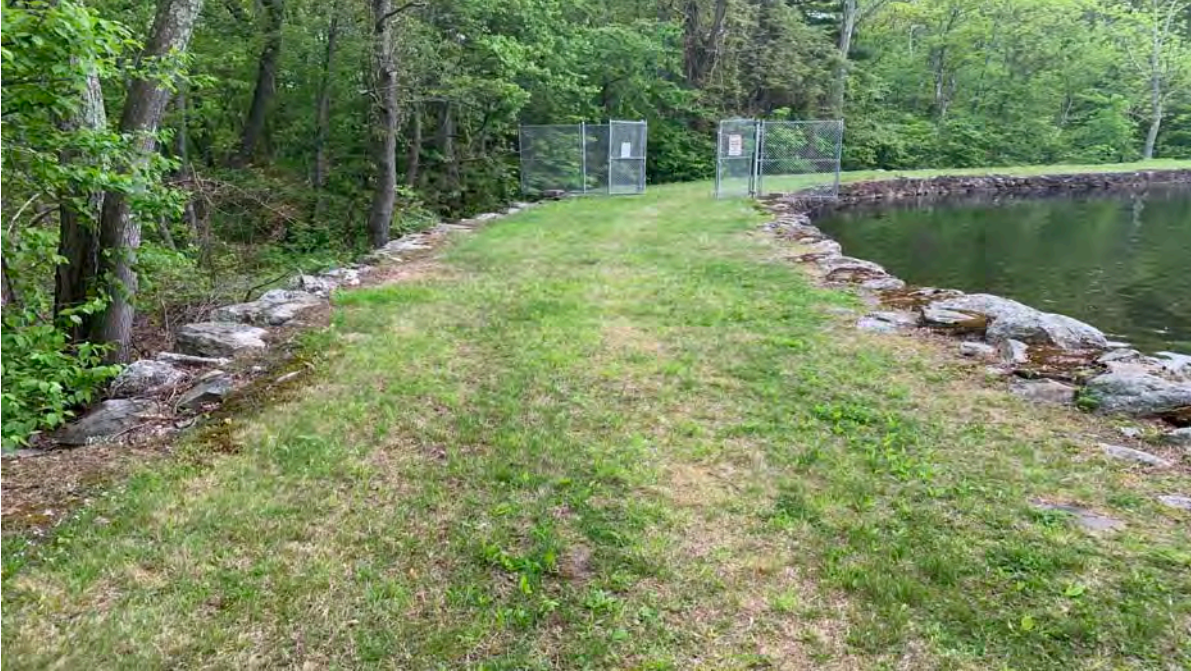
Photo 7: Left crest from the left abutment – There was some thin vegetation along the crest as well as some shallow tire rutting. Note the gate located across the crest.

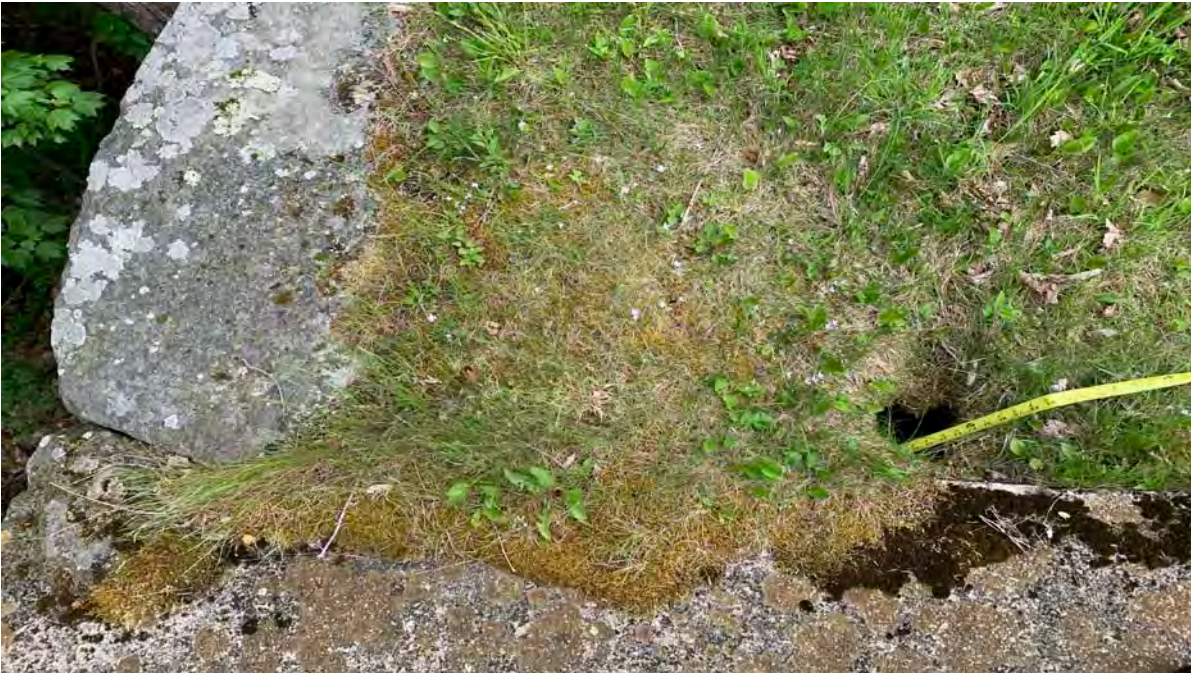
The crest was earth fill with a grass cover over most of the crest with some areas of thin vegetation. Small voids/animal burrows were observed behind the upstream and downstream masonry walls and along the right side of the right spillway training wall. Shallow tire ruts remain on left crest possibly from previous construction projects. A six inch diameter by 2 foot deep void was observed adjacent to the right spillway training wall toward the downstream side.

Photo 8: Void in right crest adjacent to the right spillway training wall.

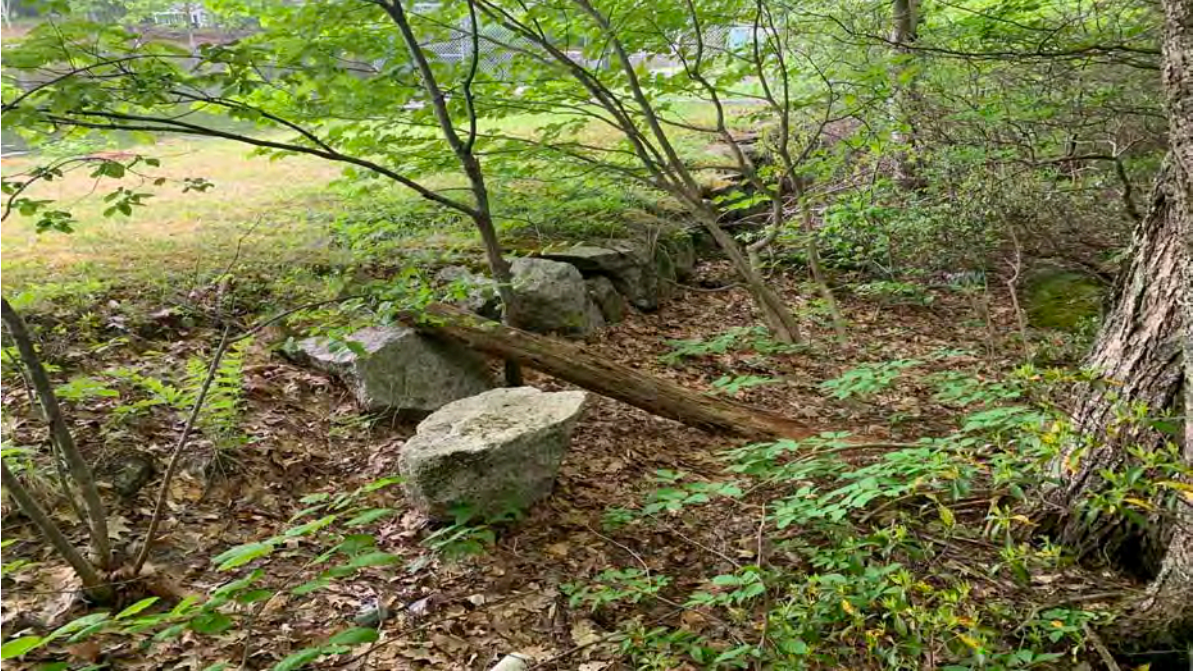
The downstream face of the dam is a near vertical dry stacked masonry wall. There are missing cap stones along top of downstream wall in multiple locations along the right side with only a few locations along the left side. Multiple large trees are growing at the immediate toe of the dam and within 20 feet. The previous report observed that there was flowing water that was audible on the downstream face of the spillway structure (no visible running water). This deficiency was not observed during this inspection.

Photo 9: Right downstream face from the right abutment – Missing cap stones along the top of the wall in multiple locations. Heavy vegetation was observed within 20 feet of the toe.

- G. Replace missing cap stones.

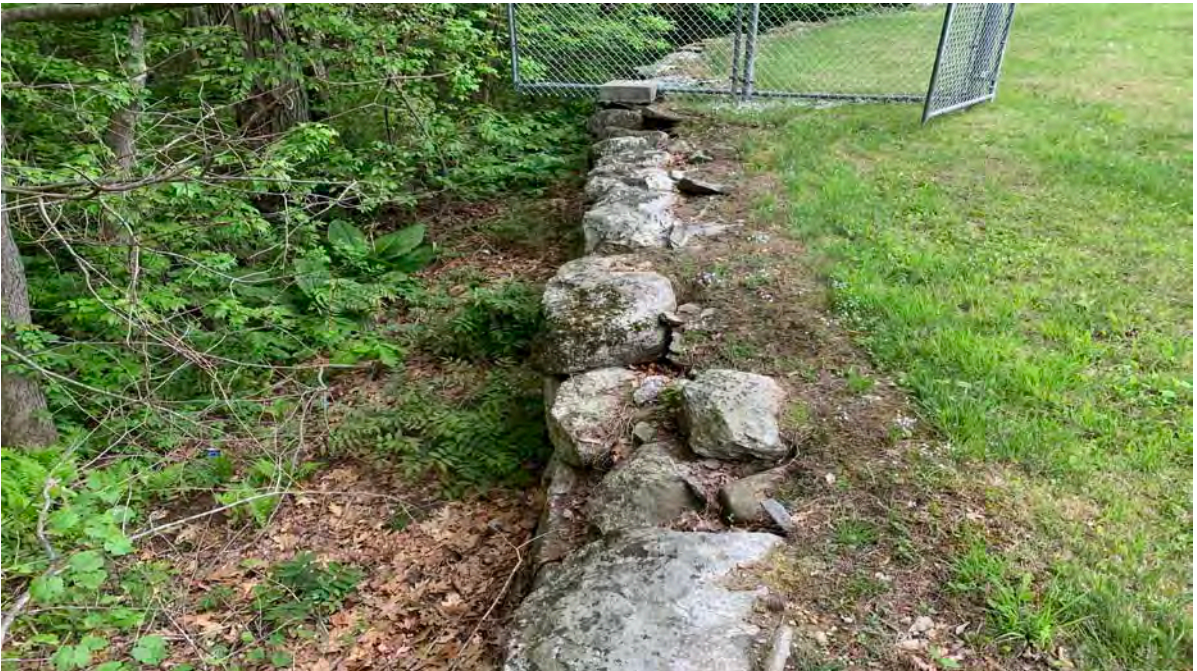
Photo 10: Left downstream face from the left abutment – Missing cap stones along the top of the wall in multiple locations. Heavy vegetation was observed within 20 feet of the toe.

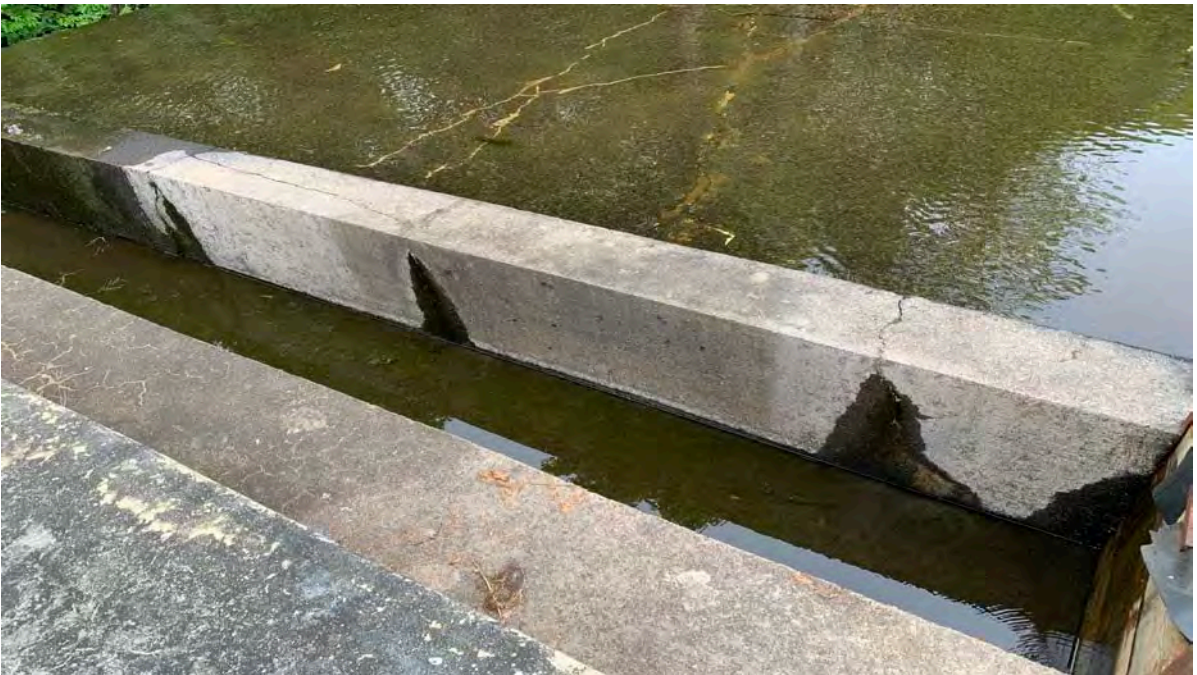
The training wall that is shared between the low flow sluiceway and primary spillway has multiple vertical through cracks with minor seepage into the low flow sluiceway. The low flow sluiceway has the ability to hold approximately five 2x8 weir boards. At the time of the inspection, all weir boards were in place. The owner's representative stated that the weir boards have been replaced recently. No signs of unusual movement were evident. Multiple cracks had been repaired in the spillway crest from previous grout repairs. The previous report observed that there was flowing water that was audible on the downstream face of the spillway structure (no visible running water). This was not observed during this inspection. The water level was approximately 0.7 feet above the left edge of the spillway at the time of the inspection.

Photo 12: Shared wall between primary spillway and low flow sluiceway. Multiple cracks were observed with seepage through the cracks.

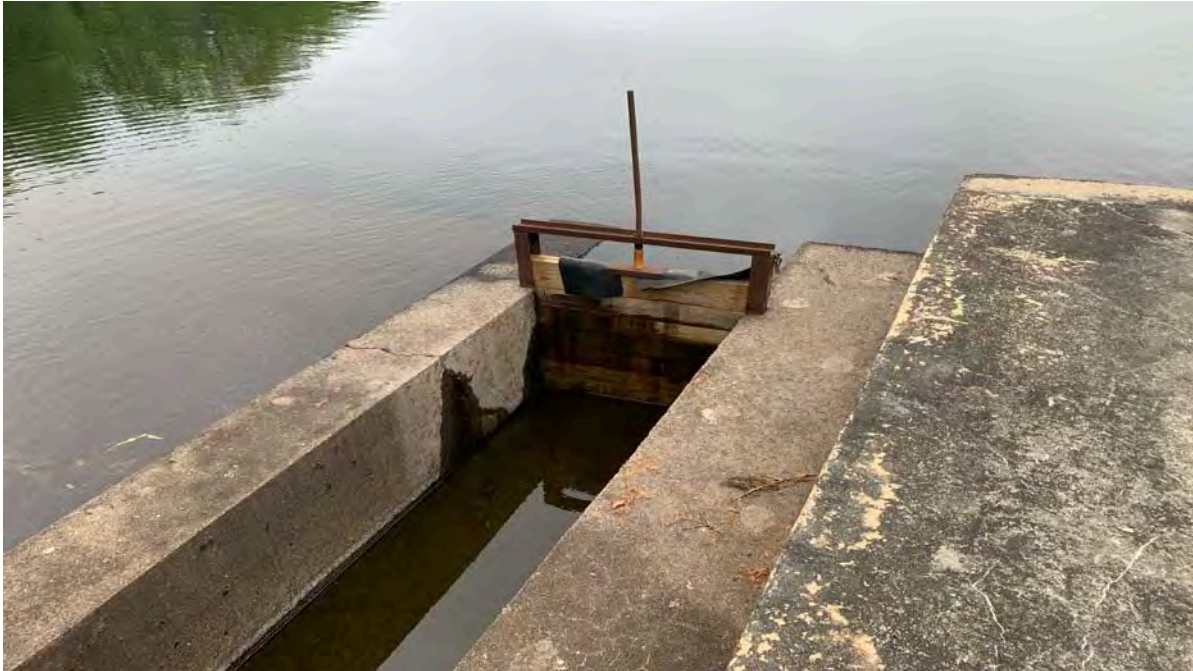
Photo 13: Inlet to the low flow sluiceway – Weir boards were in place at the time of inspection. Weir boards were recently replaced.

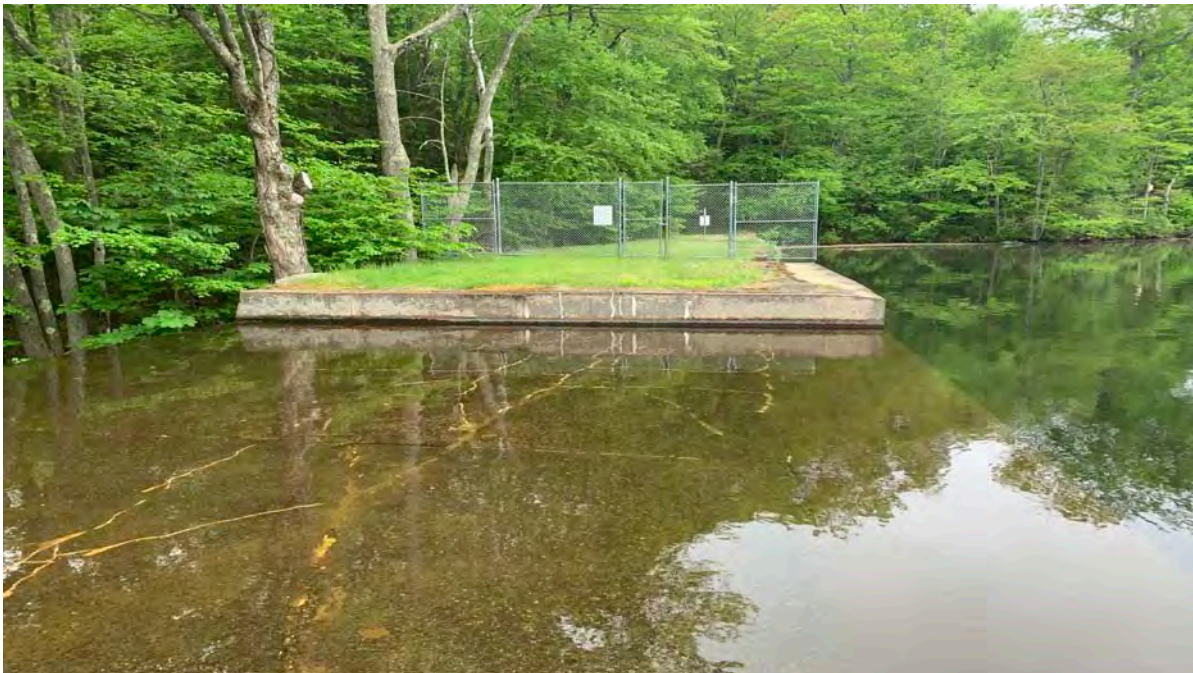
Photo 14: Primary spillway from the left crest – Cracks shown in spillway had been repaired from previous grout repairs. No deficiencies to note during this inspection.

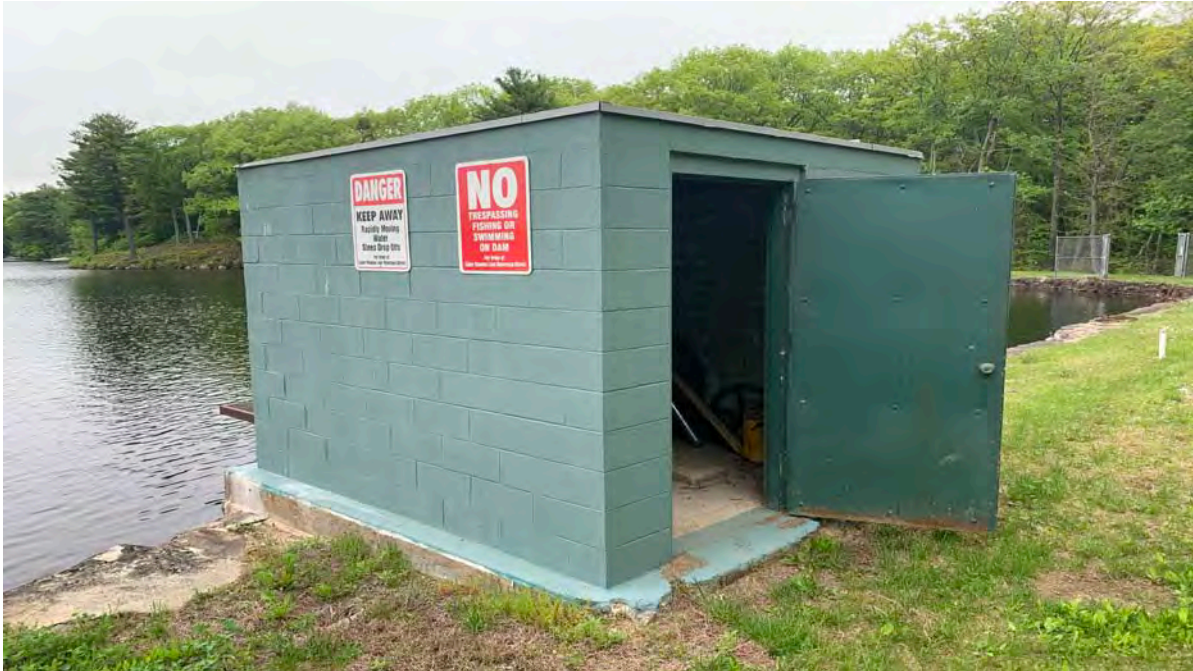
Photo 15: Gate house – The gate house was recently rebuilt but no longer serves a function other than storage. Access to the controls is through this building out onto a cantilever platform.

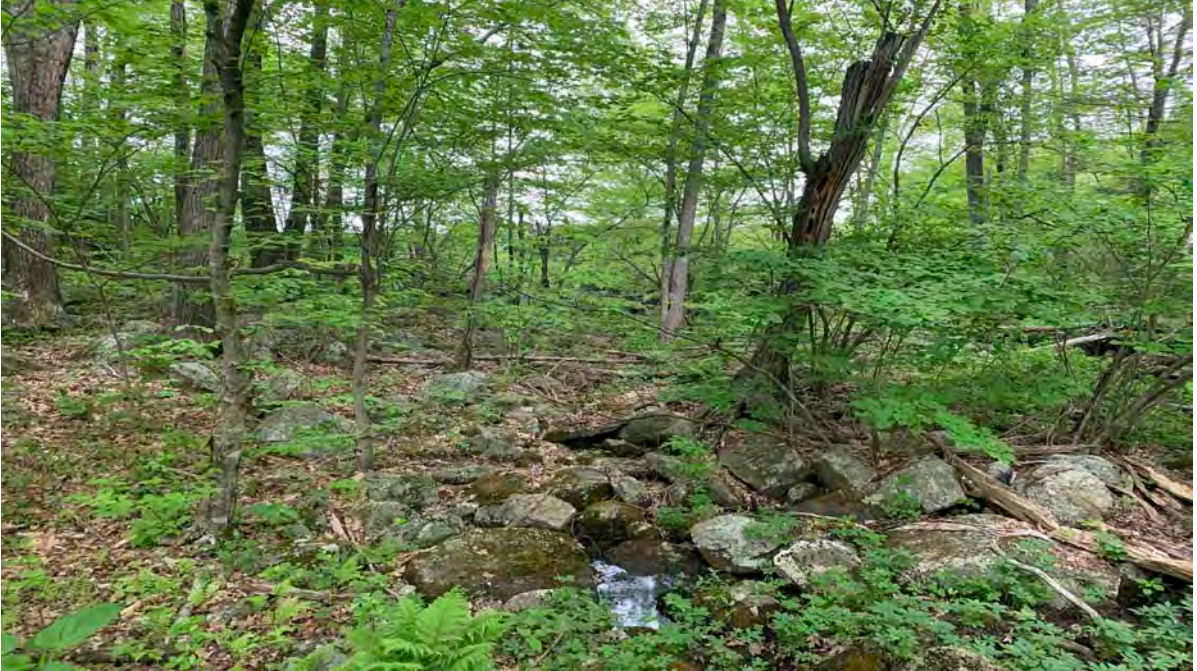
Photo 17: Downstream area along the channel looking back at the dam. The area is heavily vegetated with many trees within 20 feet of the dam toe.
