Notice of Intent and Application for Permit Waite Pond Dam Repairs

Leicester, Massachusetts

Town of Leicester

November 1, 2017

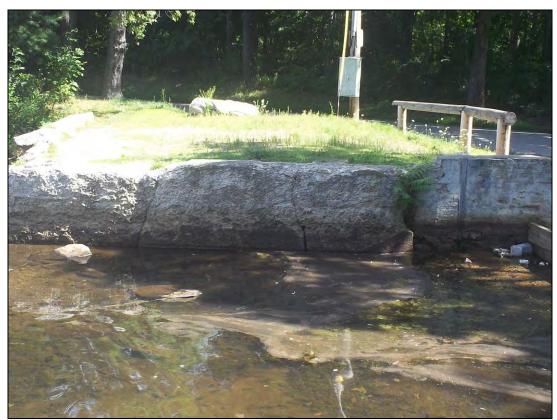
- **Primary Spillway:** The concrete training walls on both sides of the spillway are cracked and eroded. The stilling basin consists of stone rubble covered with concrete that spills overflow to the channel below. The concrete is breaking into fragments.
- Low Level Outlet: No functioning low level outlet. Low level outlet structure leaning out of plumb, concrete deteriorated, foundation undermined, and no roof. The low level outlet pipe is 50% full of sediment and its operability unknown.
- Vegetation: Dense woody vegetation is present on the right embankment crest and along the toe of the downstream retaining wall.
- Primary Spillway Training Walls: Downstream left masonry channel wall is collapsing.
- Downstream Area and Abutments: Trees and brush within 20 feet of the dam and abutments.

Photo 12: Overview of left training wall

- 1. Remove gate house Backfill existing low level outlet pipe with grout and abandon in place.
- 2. Remove upstream concrete/masonry walls.
- 3. **Replace concrete training walls.** The training walls will be replaced with up to one foot thick reinforced concrete along both training walls and will be set to a top elevation of 824.0'.

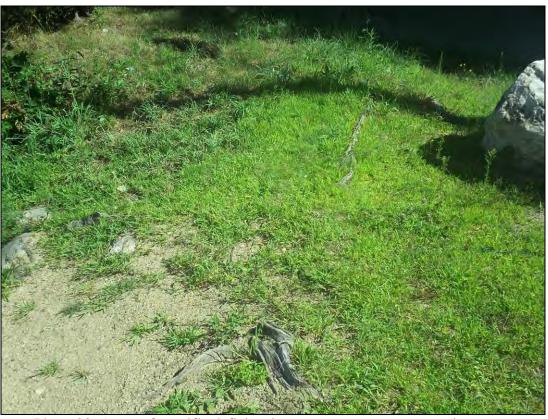
Photo 20: Areas of specific deficiencies-tree roots, sparse vegetative cover

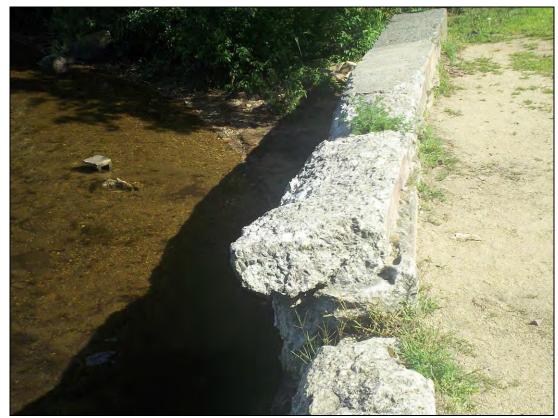
- Upstream Face: Severe erosion, cracking, and undermining of both of the concrete retaining walls observed. The left retaining wall is leaning towards the impoundment.
- Embankment Crest: The crest of the dam consists of vegetated earth. Subsidence/depressions were observed on the right and left crests. Dense small woody vegetation and tree root encroachment were also observed on the left crest.

Photo 21: Areas of specific deficiencies-deteriorating concrete, leaning wall

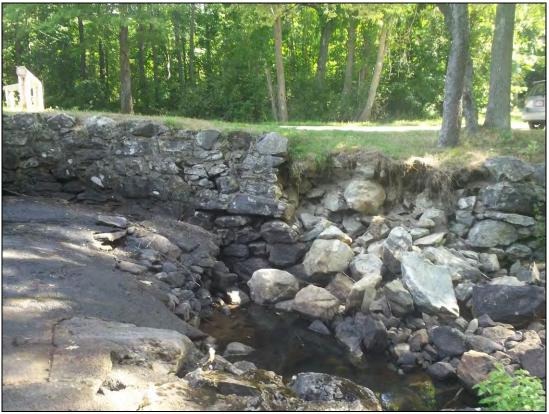
Photo 22: Areas of specific deficiencies-collapsed masonry wall

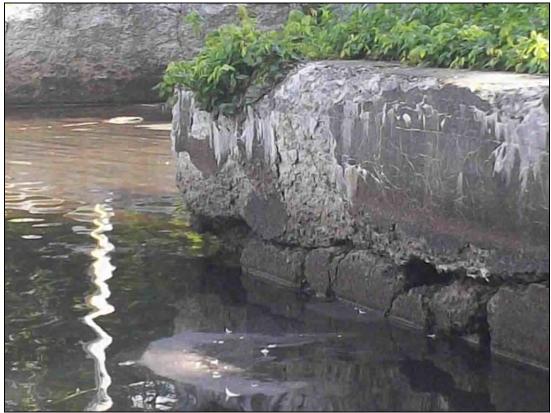
Photo 23: Areas of specific deficiencies-undermined cracked wall
