INDOOR AIR QUALITY ASSESSMENT

**Leicester Middle School
70 Winslow Avenue
Leicester, Massachusetts**

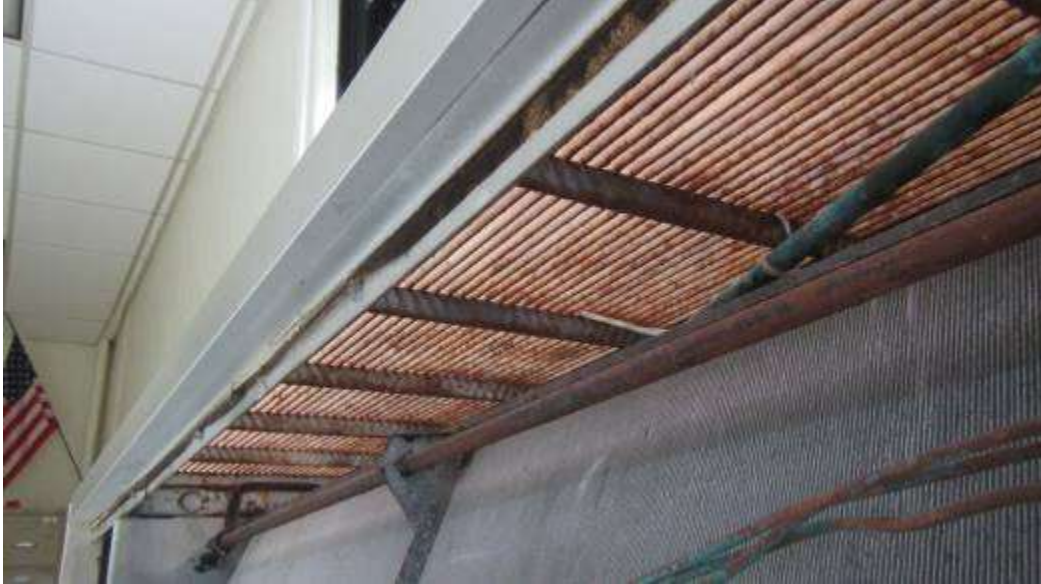
Univalent corrosion, interior

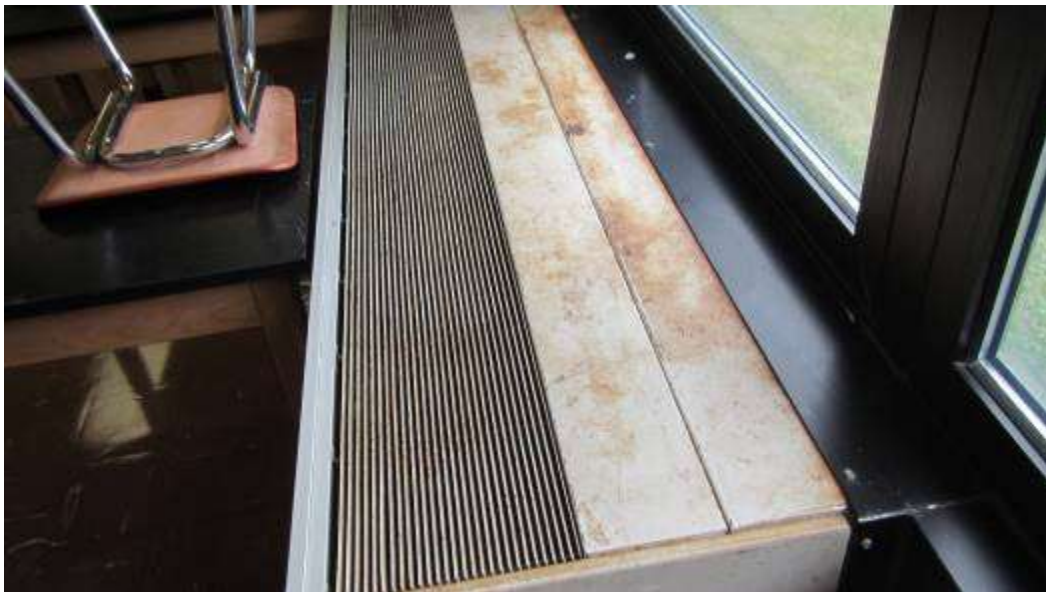
Univalent corrosion, exterior

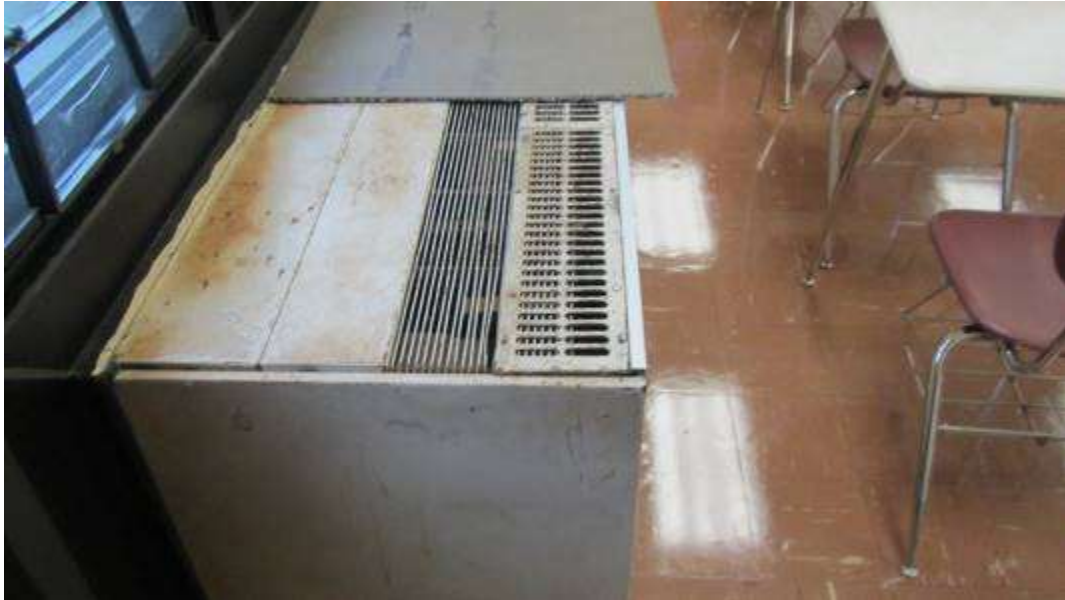
Steel grate over univent

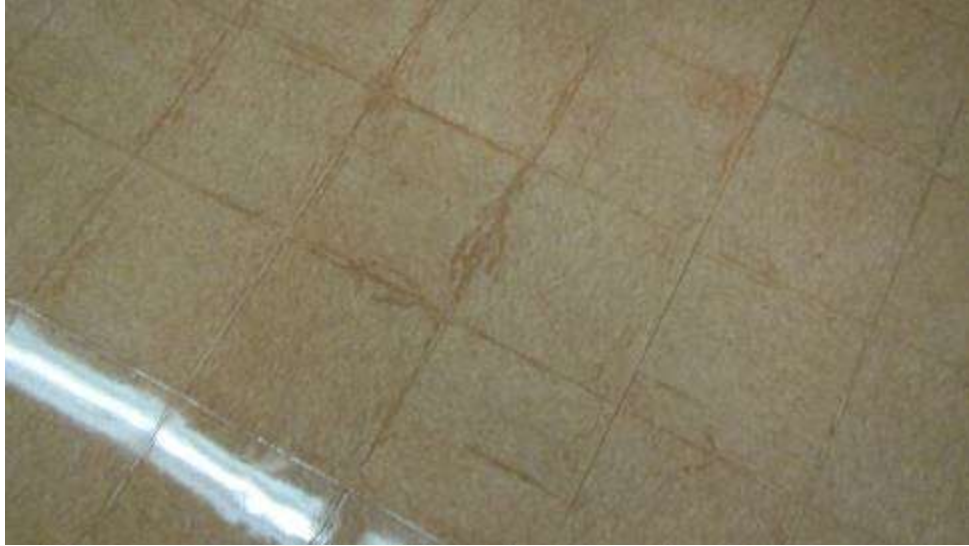
Staining of floor tile edges can be a sign of repeated condensation exposure

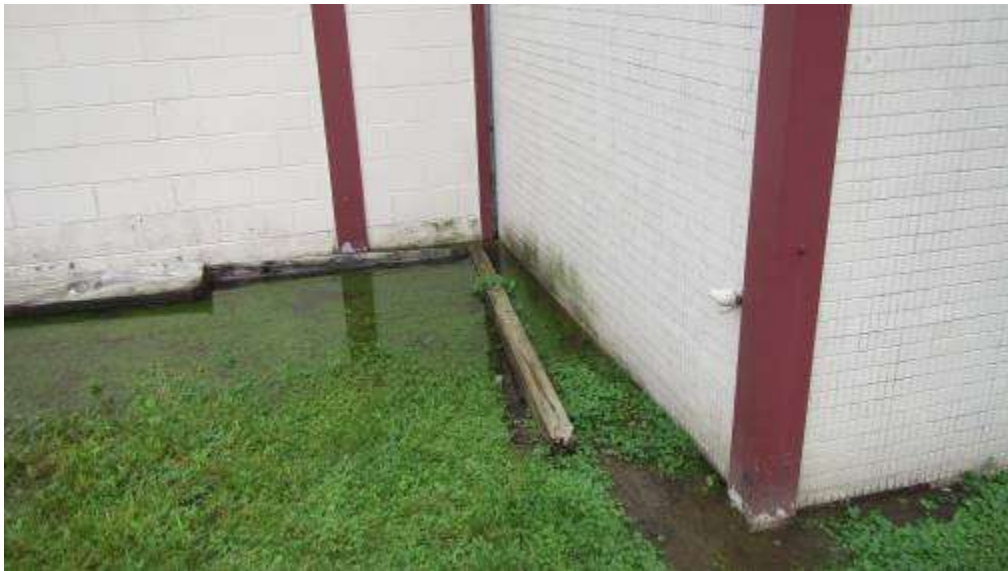
Furrow-like depression of exposed dirt adjacent to the building slab, note pooled water

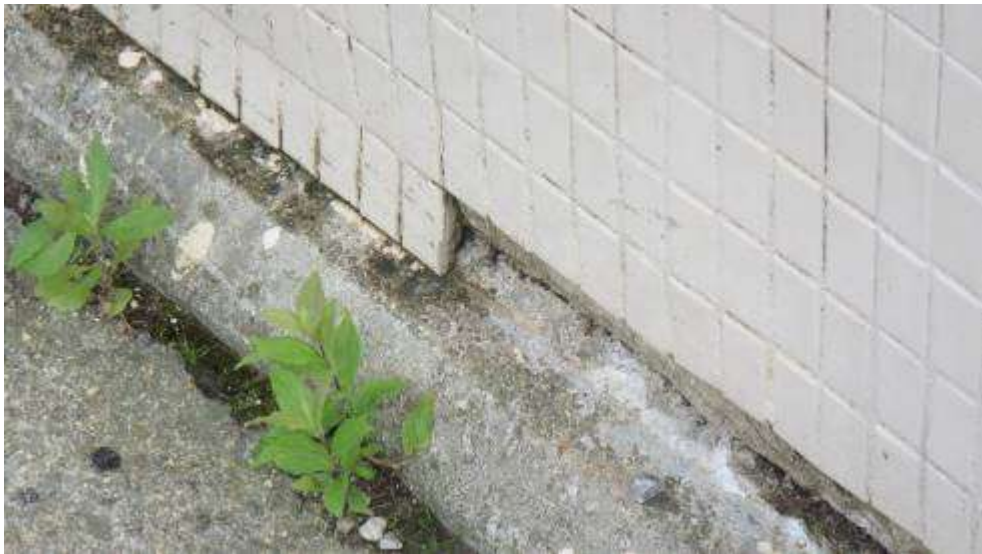
Damage at the exterior wall/slab junction; note no flashing at this joint

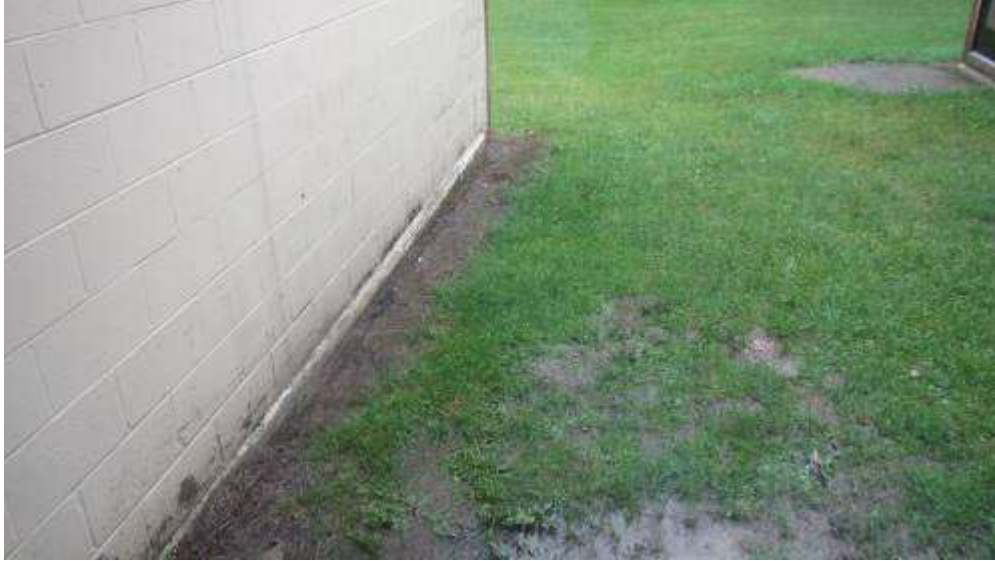
Example of flashing on other exterior walls of LMS

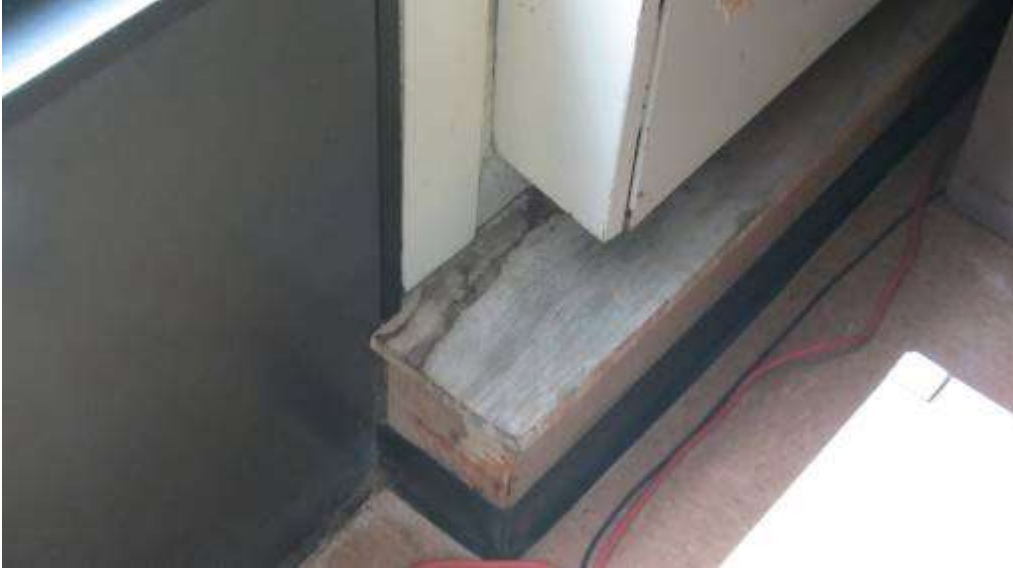
Water-damaged wood beneath radiator valves
