**Notice of Intent
Leicester Conservation
Commission**

**A127/B128 Transmission Line
Bypass Project**

**RE: A127/B128 Transmission Line Bypass Project
New England Power Company
Notice of Intent (NOI)**

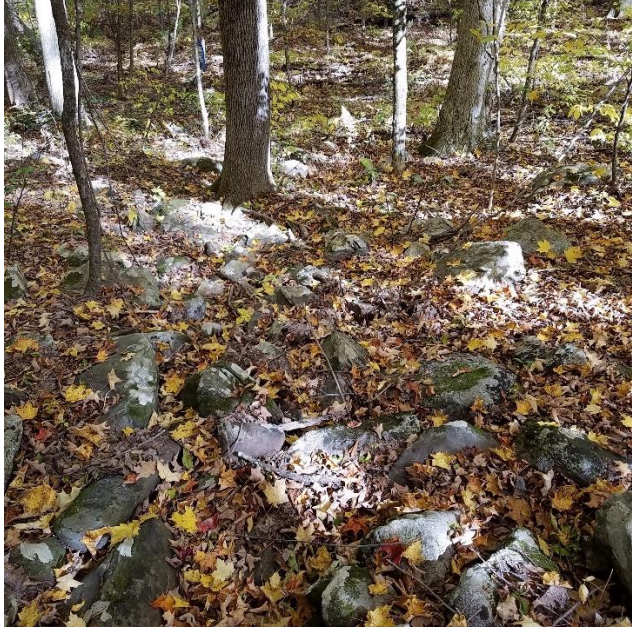
NATIONAL GRID STAFFORD STREET SUBSTATION, LEICESTER, MASSACHUSETTS	
Photograph: 1 Date: 10/15/2019 Direction: Unknown Description: Conditions observed at ephemeral drainage D- DJH-S1.

Drainage D-DJH-1 is a non-jurisdictional drainage feature (NJD) that flows through into wetland W-DJH-1 from surrounding uplands. The streambed was comprised of cobbles and leaf litter. TRC observed an average width of approximately 4 feet and no flow at the time of the survey. NJD D-DJH-1 has defined banks such that the OHWM and the banks are coincident. The centerline was delineated.

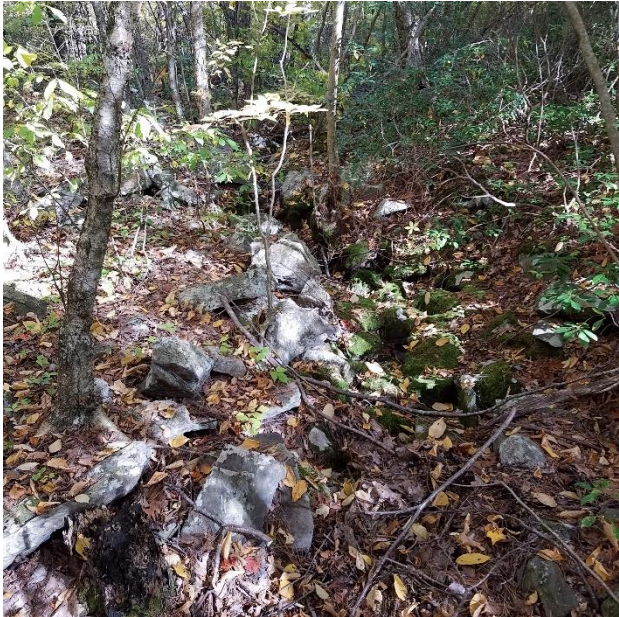
Photograph: 2 Date: 10/15/2019 Direction: West Description: Conditions observed at intermittent stream S- DJH-S2 looking upstream.

Stream S-DJH-2 is an intermittent stream (R4) that flows out of wetland W-DJH-1 to the east. The streambed was comprised of cobbles. TRC observed an average width of approximately 4 feet and no flow at the time of the survey. Stream S-DJH-2 has defined banks such that the OHWM and the banks are coincident. The centerline of the stream was delineated. This stream is located just outside the limits of the Parcel but its buffer zone overlaps the Parcel.

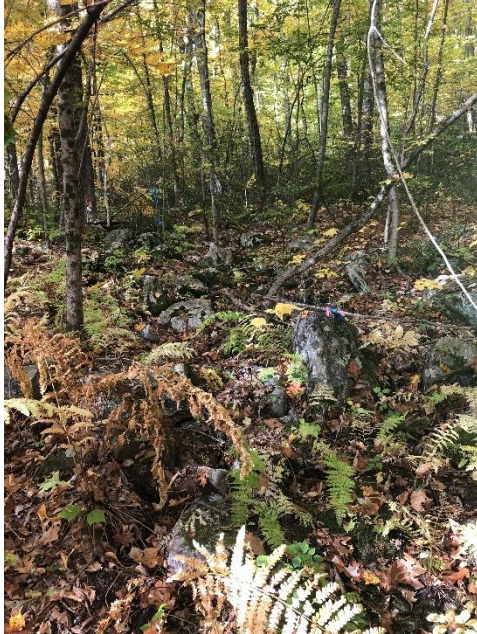
NATIONAL GRID STAFFORD STREET SUBSTATION, LEICESTER, MASSACHUSETTS	
<p>Photograph: 3</p> <p>Date: 10/16/2019</p> <p>Direction: East</p> <p>Description:</p> <p>Conditions observed at ephemeral stream S-GR-S1 looking upstream.</p>

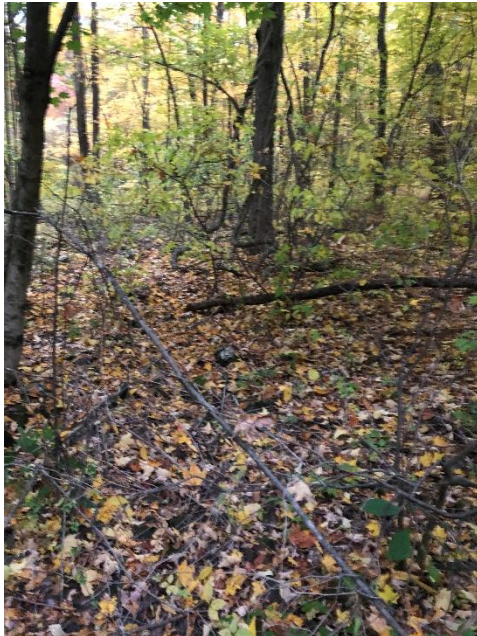
A photograph of a forest stream. The water is shallow and flows over a bed of rocks and fallen leaves. The surrounding forest is dense with trees and undergrowth, including many ferns and fallen branches.
<p>Photograph: 4</p> <p>Date: 10/16/2019</p> <p>Direction: East</p> <p>Description:</p> <p>Conditions observed at ephemeral stream S-GR-S2 looking downstream.</p>

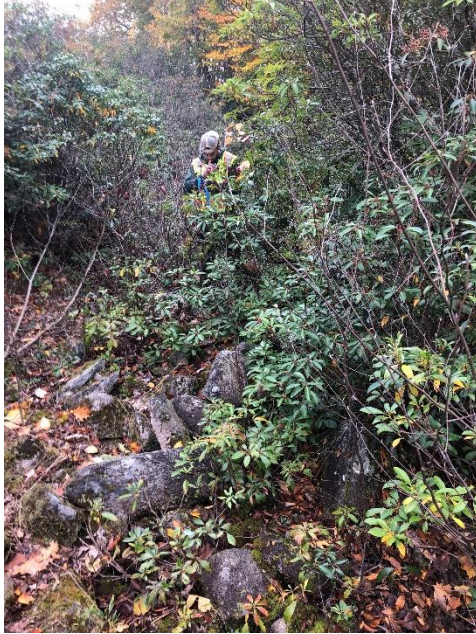
NATIONAL GRID STAFFORD STREET SUBSTATION, LEICESTER, MASSACHUSETTS	
<p>Photograph: 5</p> <p>Date: 10/18/2019</p> <p>Direction: South</p> <p>Description:</p> <p>Conditions observed at ephemeral drainage D-GR-S3 looking upstream.</p>

Drainage D-GR-3 is a non-jurisdictional drainage feature (NJD) that flows out of uplands next to wetland W-GR-4 but does not connect to the wetland or any other waterbody. The streambed was comprised of cobbles and leaf litter. TRC observed an average width of approximately 5 feet and no flow at the time of the survey. NJD D-GR-3 has defined banks such that the OHWM and the banks are coincident. The centerline was delineated.

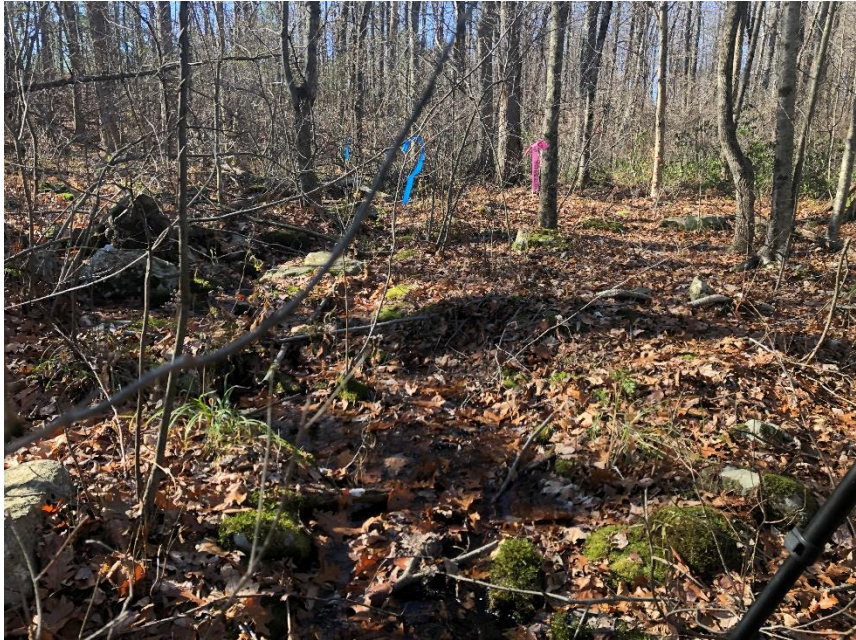
<p>Photograph: 6</p> <p>Date: 11/13/2019</p> <p>Direction: Southwest</p> <p>Description:</p> <p>Conditions observed at intermittent stream S-GR-S4 looking upstream.</p>

Stream S-GR-4 is an intermittent stream (R4) that flows through narrow sections of wetland W-GR-2 ultimately dissipating within the wetland. The streambed was comprised of cobbles. TRC observed an average width of approximately 3 feet and a water depth of approximately 2 inches. Stream S-GR-4 has defined banks such that the OHWM and the banks are coincident. The centerline of the stream was delineated.

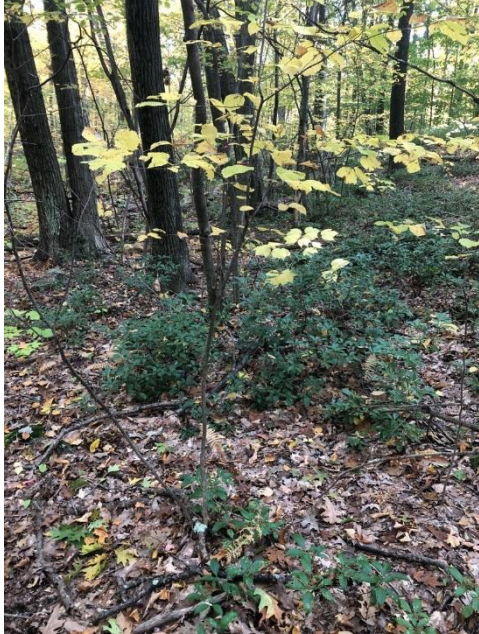
A photograph showing a forest floor with a mix of green and yellow leaves, indicating early autumn. The ground is covered with fallen leaves and some green plants are still growing. The background shows several tree trunks.
<p>Photograph: 8</p> <p>Date: 10/22/2019</p> <p>Direction: South</p> <p>Description:</p> <p>Typical conditions observed at wetland data point GR-W1-PFO .</p>

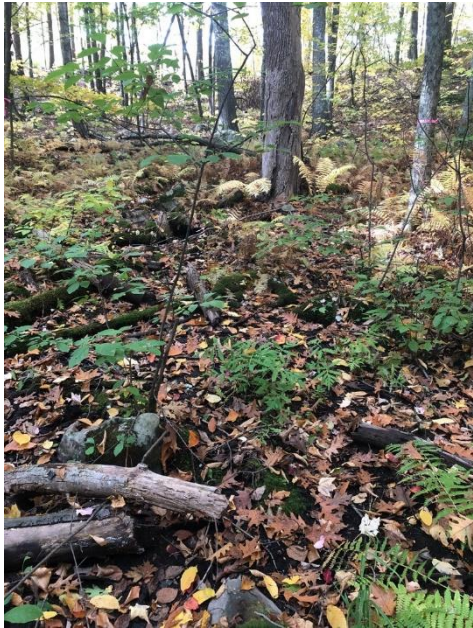
NATIONAL GRID STAFFORD STREET SUBSTATION, LEICESTER, MASSACUSETTS	
<p>Photograph: 9</p> <p>Date: 10/16/2019</p> <p>Direction: West</p> <p>Description:</p> <p>Typical conditions observed at upland data point GR-W2-UPL.</p>

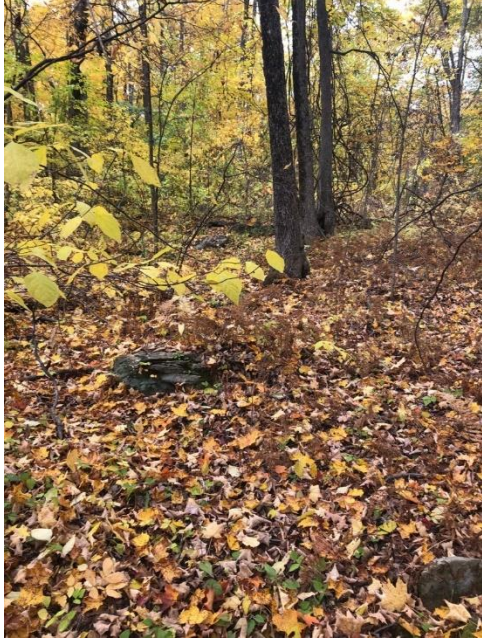
<p>Photograph: 10</p> <p>Date: 10/16/2019</p> <p>Direction: South</p> <p>Description:</p> <p>Conditions observed at wetland W2 data point GR-W2-PFO.</p>

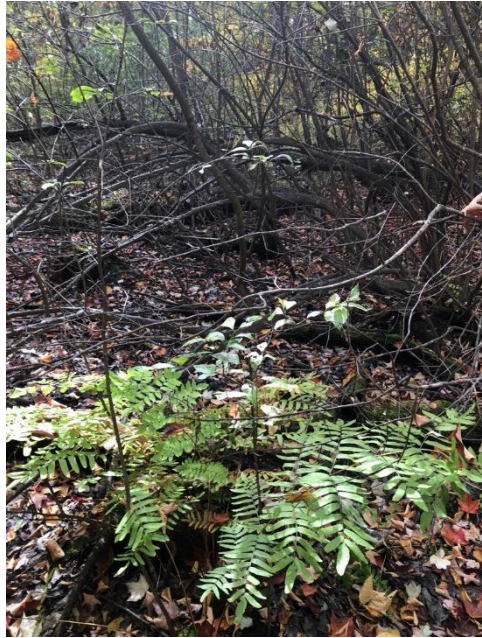
NATIONAL GRID STAFFORD STREET SUBSTATION, LEICESTER, MASSACHUSETTS	
<p>Photograph: 11</p> <p>Date: 10/16/2019</p> <p>Direction: North</p> <p>Description:</p> <p>Typical conditions observed at upland data point GR-W3-UPL1.</p>

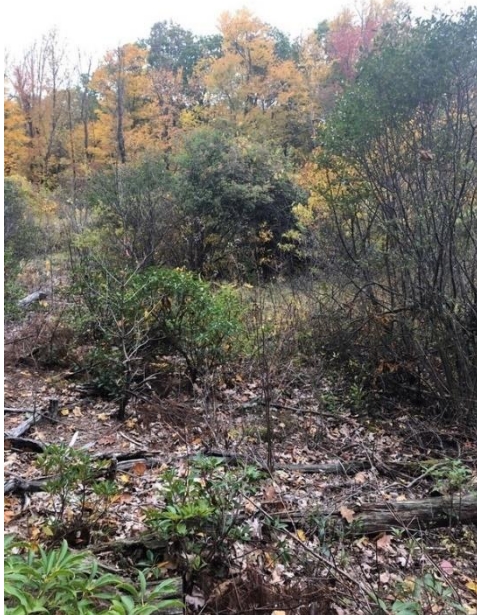
<p>Photograph: 12</p> <p>Date: 10/16/2019</p> <p>Direction: South</p> <p>Description:</p> <p>Conditions observed at wetland W3 data point GR-W3-PSS.</p>

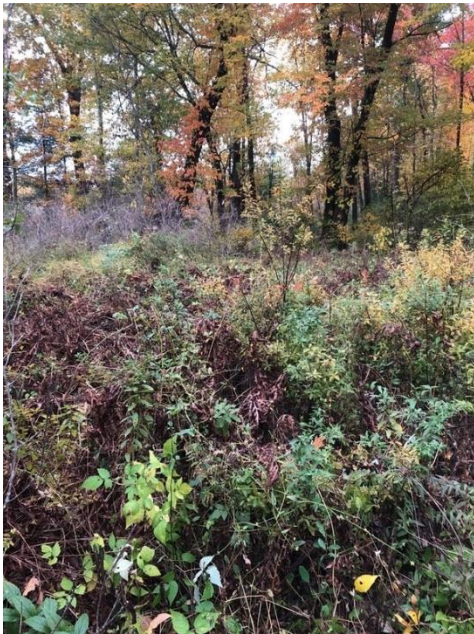
NATIONAL GRID STAFFORD STREET SUBSTATION, LEICESTER, MASSACHUSETTS	
<p>Photograph: 13</p> <p>Date: 10/16/2019</p> <p>Direction: South</p> <p>Description:</p> <p>Typical conditions observed at upland data point GR-W3-UPL2.</p>

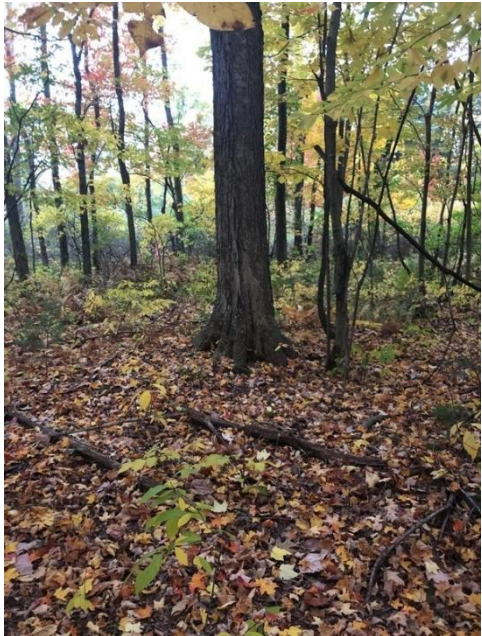
<p>Photograph: 14</p> <p>Date: 10/16/2019</p> <p>Direction: East</p> <p>Description:</p> <p>Conditions observed at wetland W3 data point GR-W3-PFO.</p>

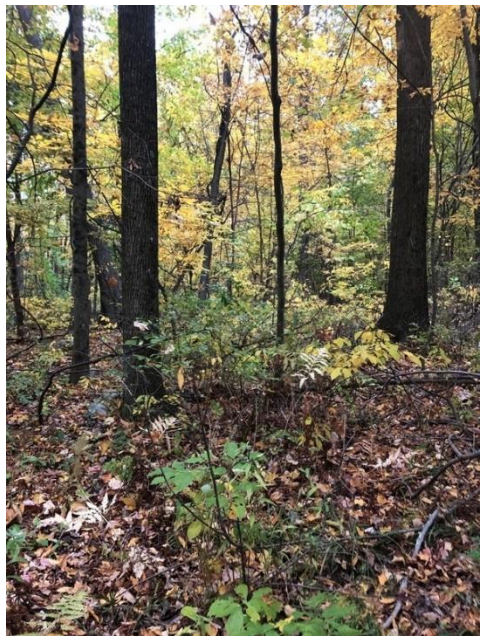
NATIONAL GRID STAFFORD STREET SUBSTATION, LEICESTER, MASSACHUSETTS	
Photograph: 15 Date: 10/16/2019 Direction: North Description: Typical conditions observed at upland data point GR-W4-UPL.

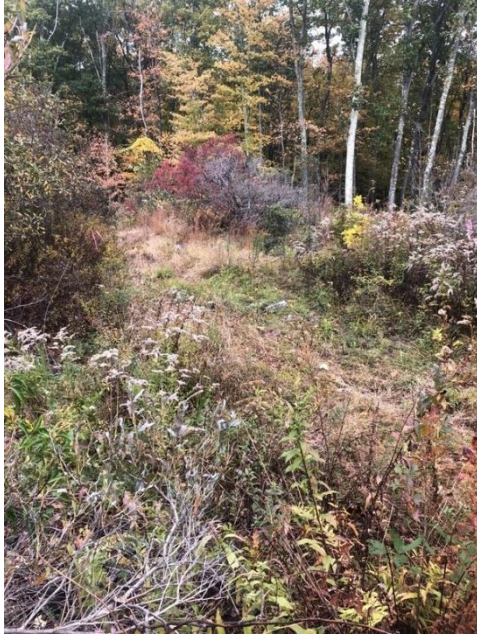
Photograph: 16 Date: 10/16/2019 Direction: West Description: Conditions observed at wetland W4 data point GR-W4-PSS.

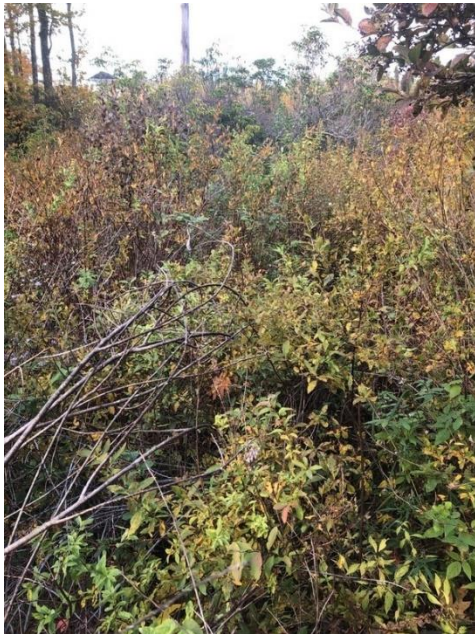
NATIONAL GRID STAFFORD STREET SUBSTATION, LEICESTER, MASSACHUSETTS	
<p>Photograph: 17</p> <p>Date: 10/15/2019</p> <p>Direction: North</p> <p>Description:</p> <p>Typical conditions observed at upland data point DJH-W1-UPL.</p>

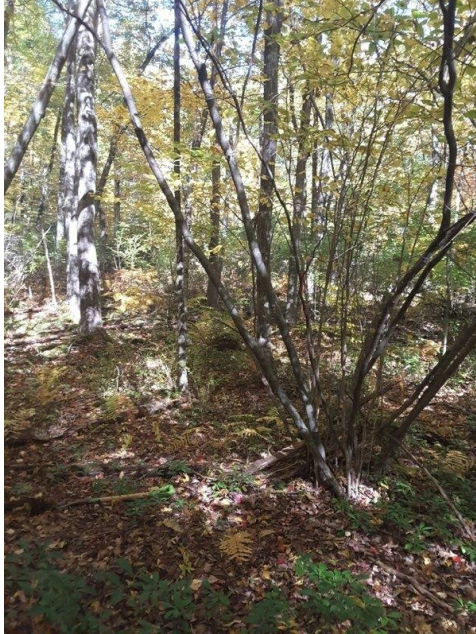
<p>Photograph: 18</p> <p>Date: 10/15/2019</p> <p>Direction: West</p> <p>Description:</p> <p>Conditions observed at wetland W1 data point DJH-W1-PFO.</p>

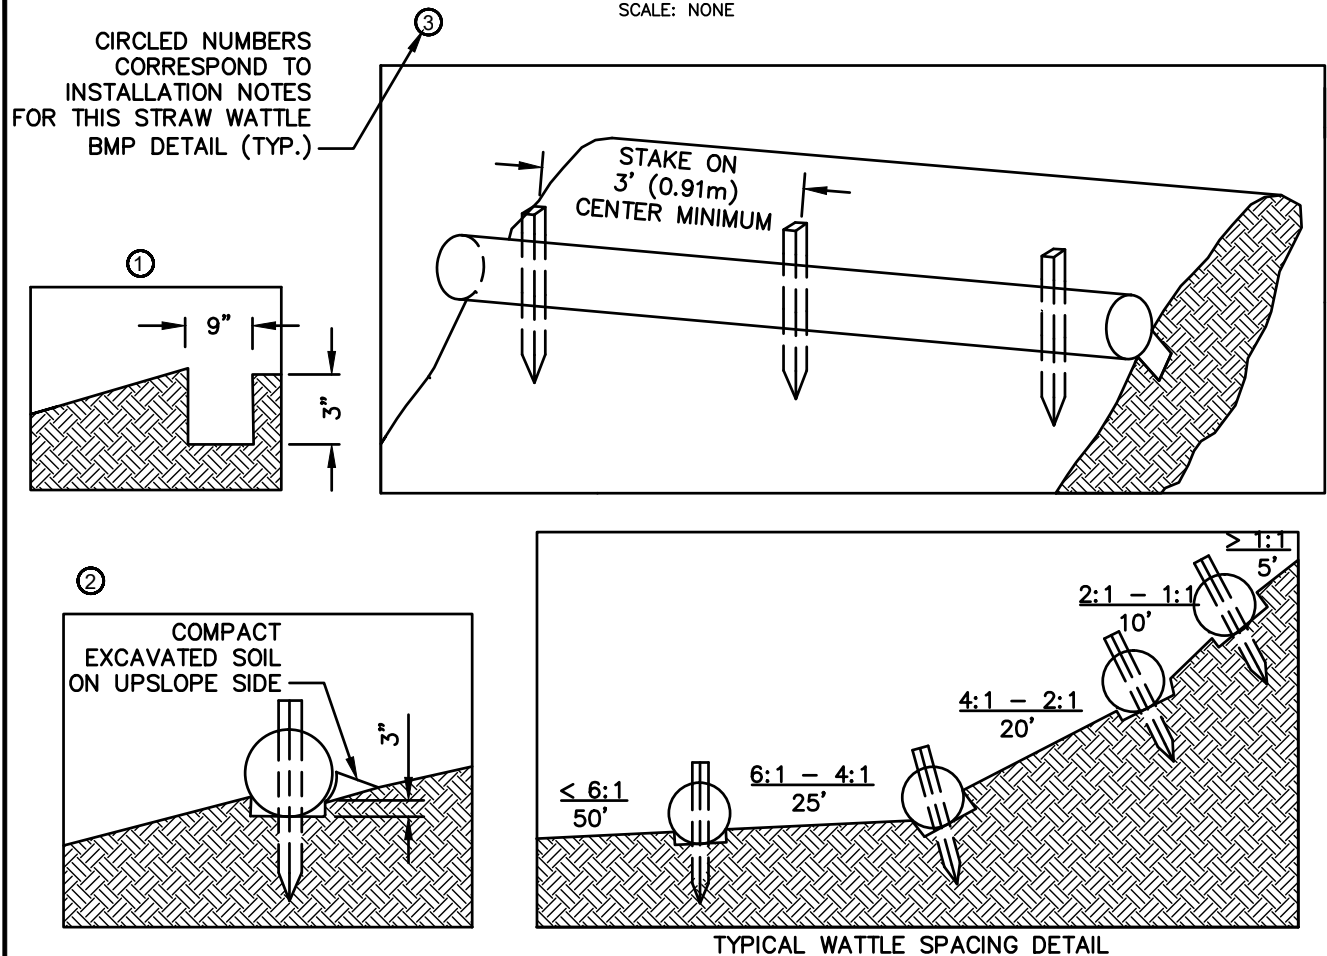
BMP DETAIL

1. PRODUCT TO BE TENSAR NORTH AMERICAN GREEN STRAW WATTLE OR APPROVED EQUAL BY NATIONAL GRID ENVIRONMENTAL SCIENTIST.
2. TYPICAL WATTLE SPACING BASED ON SLOPE GRADIENT. COORDINATE SPACING AND LOCATION WITH NATIONAL GRID ENVIRONMENTAL SCIENTIST.
3. MINIMUM 12" DIAMETER WATTLES SHOULD BE USED FOR HIGHLY DISTURBED AREAS (I.E., HEAVILY USED ACCESS ROAD WITH ADJACENT WETLAND) AND MINIMUM 9-10" WATTLES SHOULD BE USED FOR LESS DISTURBED SOILS.

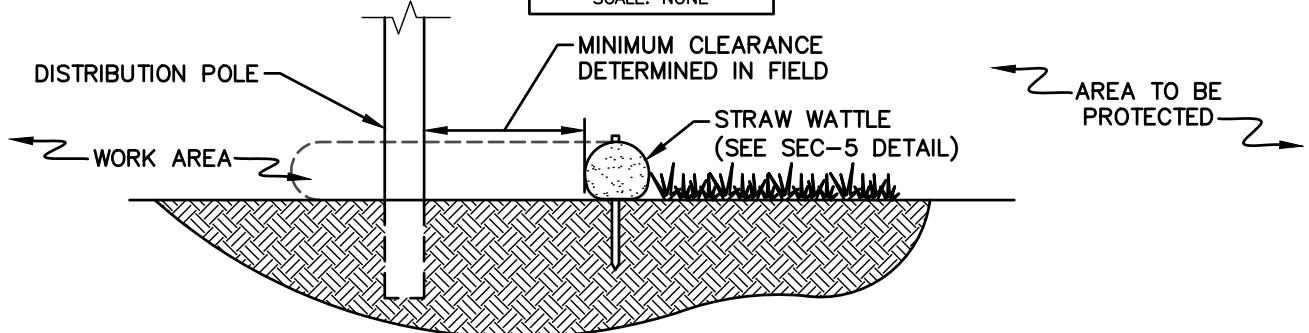
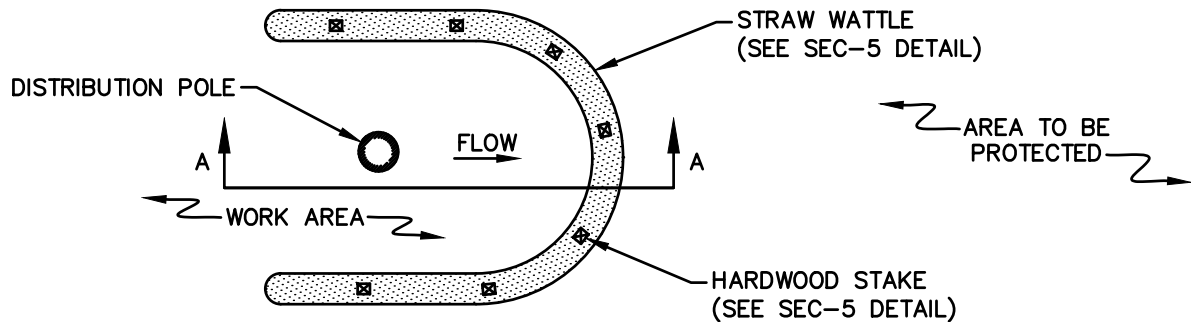
SECTION A-A

1. PRODUCT TO BE STRAW WATTLE OR APPROVED EQUAL BY NATIONAL GRID ENVIRONMENTAL SCIENTIST (SEE SEC-5 BMP DETAIL).
2. STRAW BALE BARRIER PER SEC-1 BMP DETAIL TO BE AN AVAILABLE ALTERNATE DEPENDING ON SITE CONDITIONS AT THE DIRECTION OF NATIONAL GRID ENVIRONMENTAL SCIENTIST (SEE FIGURE 2).
3. MINIMUM CLEARANCE BETWEEN POLE AND EROSION CONTROL TO BE DETERMINED BY CONDITIONS OF POLE INSTALLATION/REPLACEMENT WORK AND ASSOCIATED DISTURBANCE.

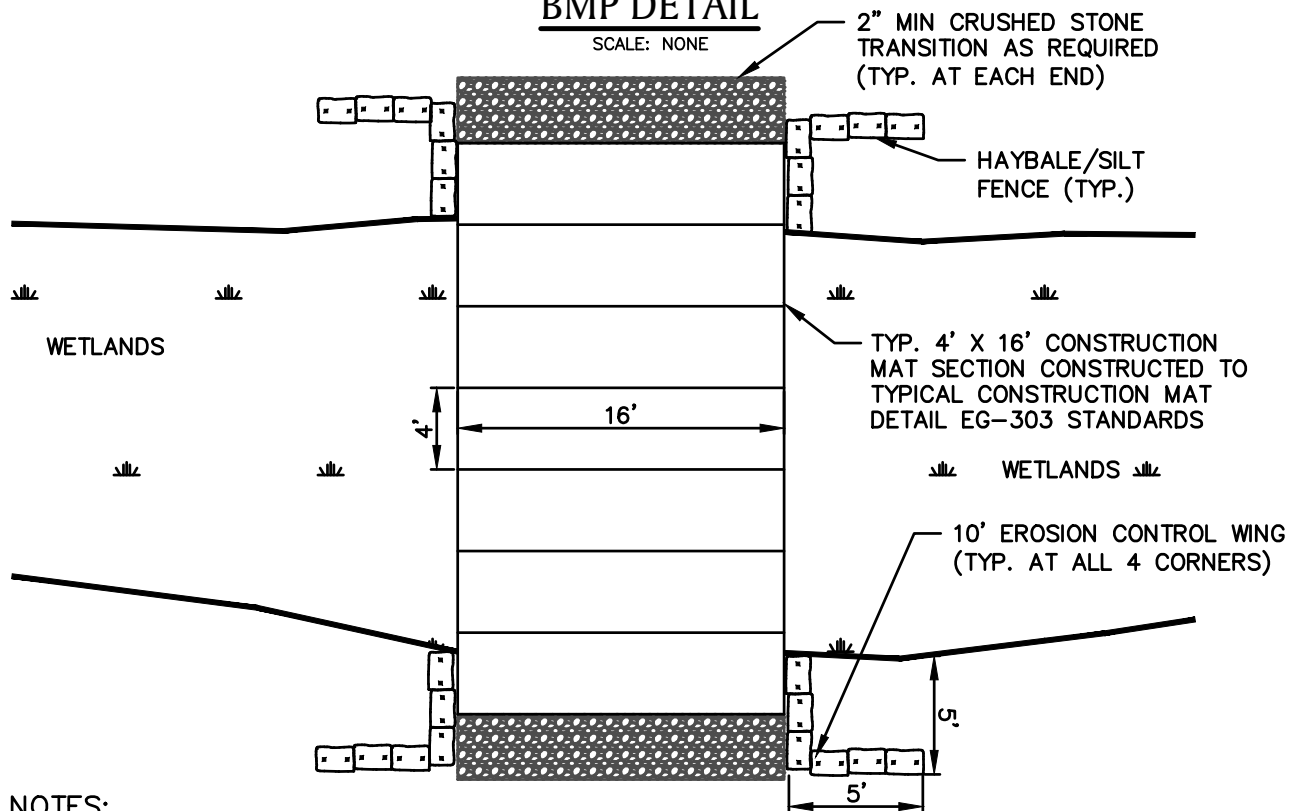
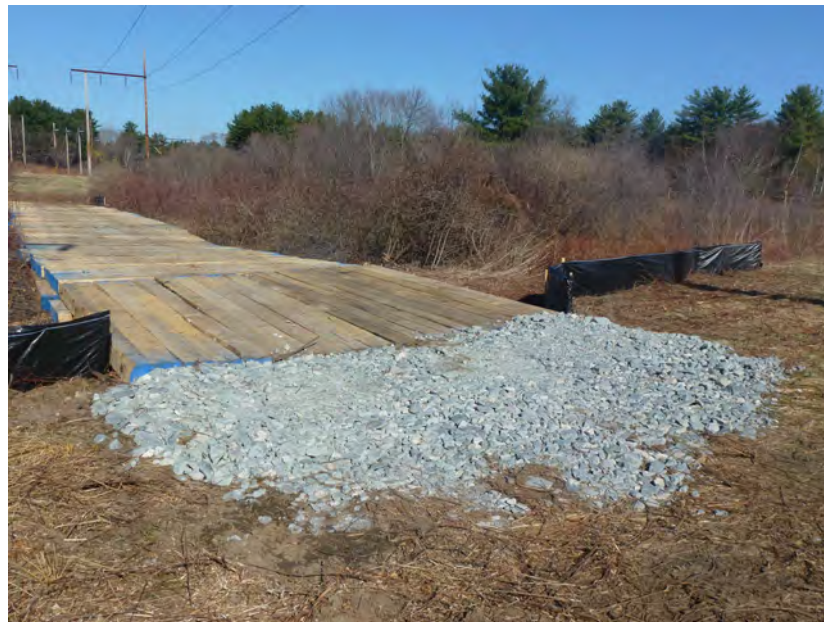
CONSTRUCTION MAT LAYOUT
(WITH TRANSITION AND BMPs)

1. ADD FILTER FABRIC AS NEEDED UNDER STONE TRANSITION RAMPS.
2. ALL MEASUREMENTS AND LOCATIONS ARE APPROXIMATE.

- having an Environmental Inspector/Monitor on-site during construction;
- avoiding significant disturbance to regulated wetlands;
- using construction mats for equipment access to the wetland, which avoids rutting and direct soil disturbance;
- using erosion controls where an erosion hazard exists;
- restoring altered areas to pre-construction conditions by applying a wetland seed mix and or mulching with straw, if necessary;
- keeping spill response equipment on-hand and ready for deployment in the event of a spill; and
- refueling any equipment outside the BVW and buffer zone.
