-- Waite Pond Dam --PHASE II INVESTIGATIONS REPORT

Dam Name: Waite Pond Dam State Dam ID#: 3-14-151-21 NID#: MA00987 Owner: Town of Leicester Owner Type: Municipal Town: Leicester Consultant: Fuss & O'Neill, Inc. Date of Completion: August 4, 2014

Waite Pond Dam Phase II Investigations Report Town of Leicester

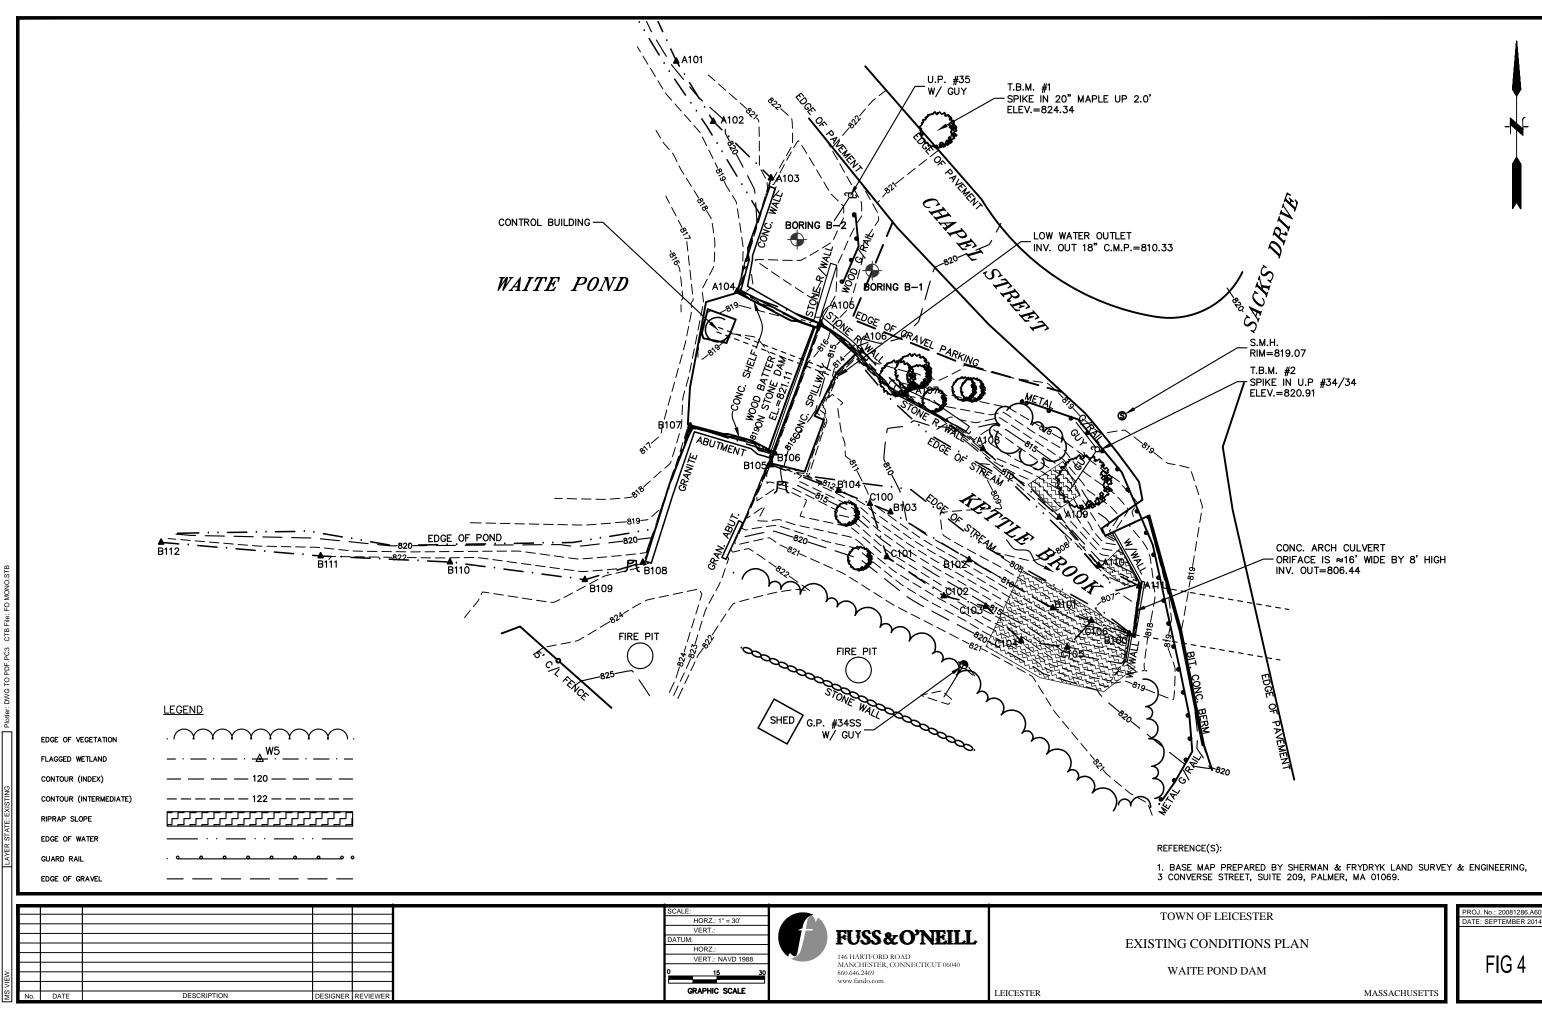
DATE: SEPTEMBER 2014
FIG 4

The upstream face of the dam is supported by concrete retaining walls. The downstream right face of the dam consists of a vertical dry-laid masonry wall. The downstream left embankment consists of a relatively flat earthen area used for parking, supported along the stream by a vertical masonry wall that has partially collapsed. The left dam crest is isolated from the parking area by a timber post and rail fence. An existing conditions plan is provided as *Figure 4*.

The bedrock cores advanced in boring B-1 used an NQ core barrel with water-cooled diamond bit. The resulting core (2.16-inch diameter) was measured to determine the Rock Quality Designation (RQD), a measure of the relative amount of fracturing and general quality of the rock. The locations are indicated on *Figure 4*, labeled borings B-1 and B-2.

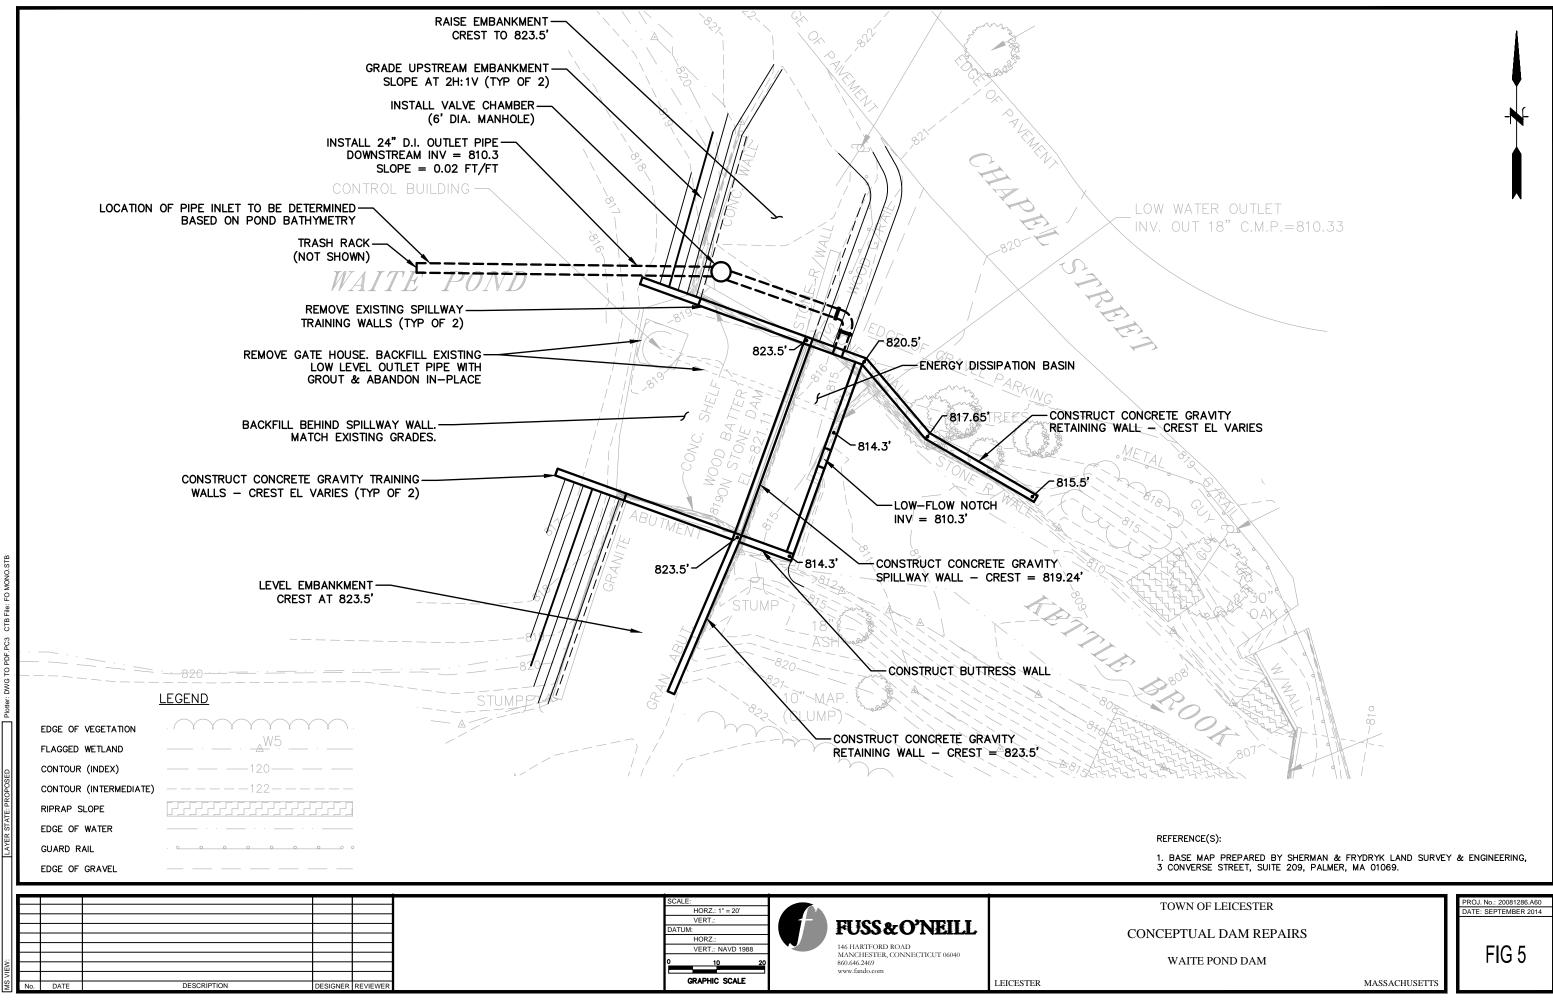
• Replace the existing stone masonry retaining wall at the downstream face of the right embankment with a concrete gravity wall. A concrete buttress is proposed for added stability of the retaining wall. As shown in *Figure 5*, the buttress would be located adjacent to

The attached plan of the dam (*Figure 5*) and immediate surrounding area indicates the locations of the repairs.

- Earth slopes, graded into the impoundment, are recommended at the upstream face of the left and right embankments. This approach will be less expensive than reconstruction of the existing concrete retaining walls.

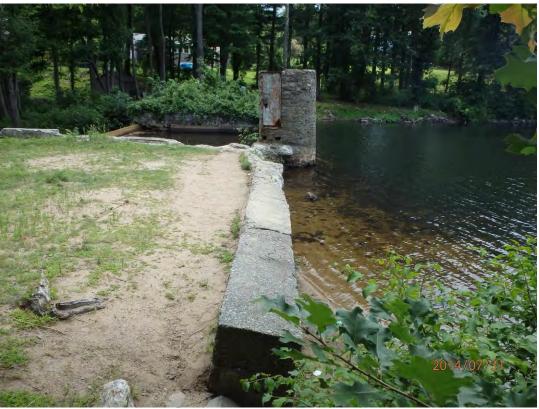
Photo 3: Overview of upstream face from left abutment

- **Upstream Face:** Severe erosion, cracking, and undermining of both of the concrete retaining walls were observed. The left retaining wall is leaning towards the impoundment.

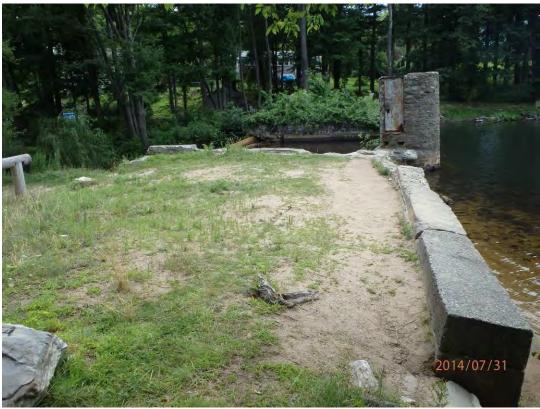
Photo 4: Overview of dam crest from left abutment

- **Embankment Crest:** The crest of the dam consists of vegetated earth. Depressions were observed on the right and left crests. Dense small woody vegetation and tree root encroachment were also observed on the left crest.

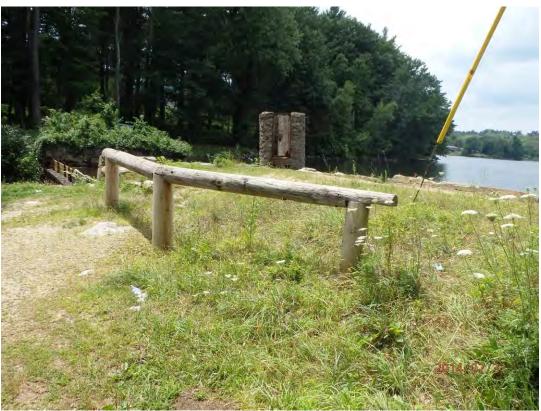
Photo 5: Overview of downstream face from left abutment

- **Downstream Face:** The right downstream face consists of vertical dry-laid stone masonry wall. The wall appears to be slightly leaning out of plumb and some stones are missing. The left downstream area consists of a gravel parking area supported by a vertical masonry wall parallel to the brook channel; a portion of this wall has collapsed.

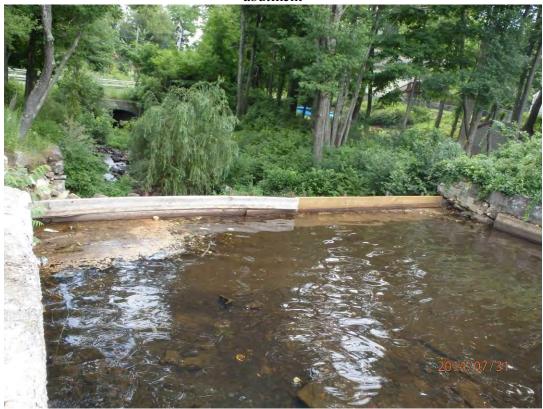
Photo 6: Overview of spillway from upstream

- **Primary Spillway:** The concrete training walls on both sides of the spillway are cracked and eroded. The stilling basin consists of stone rubble covered with concrete that spills overflow to the channel below. The concrete is breaking into fragments.

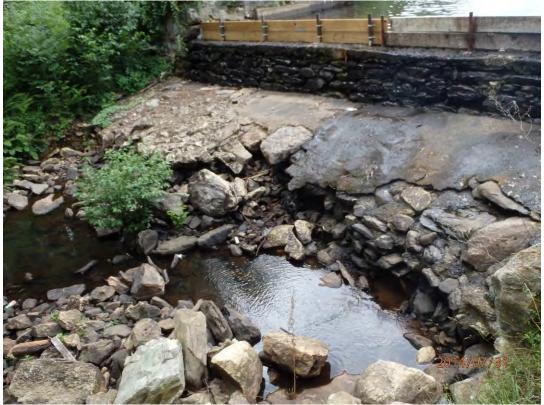
Photo 10: Overview of stilling basin & low-level outlet discharge location

- Low Level Outlet: The 24-inch CMP low level outlet is rusted and appears to be approximately ¹/₂ full of sediment; however, water was observed to be discharging from the pipe during the July 31, 2014 inspection. It is not known if this is due to leakage past the gate, or the gate having been recently opened. Sediment was not observed in the water discharging from the outlet pipe. The position/height of the gate operator stem observed during the inspection appeared to have changed relative to the previous inspection (based on photographs). It was also noted that a series of stones had been placed in the spillway channel between the left training wall and the door in the gate house, presumably for access to the gate operator.

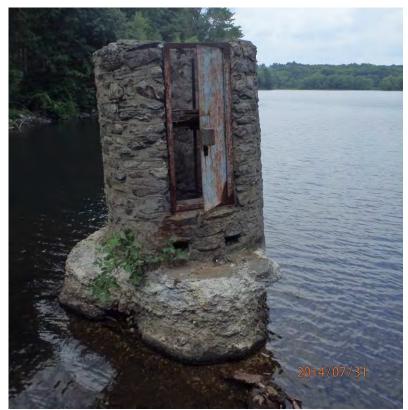
Photo 12: Overview of gatehouse exterior

- **Gate House:** The gate operator is located in a circular structure in the upstream end of the spillway channel. The structure has no roof, the walls are leaning out of plumb, and the concrete foundation is severely deteriorated. There is currently no access to the structure except by wading or boat.

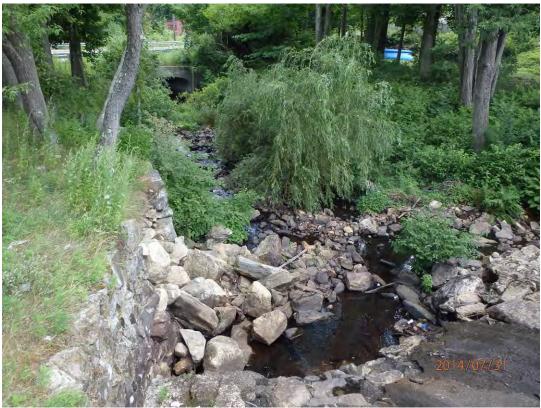
Photo 15: Areas of specific deficiencies-failing downstream channel wall

- The upstream concrete retaining walls are severely deteriorated; the left retaining wall is leaning toward the impoundment.
- The stone masonry retaining wall along the left bank of the downstream channel has collapsed. This wall partially supports the downstream face of the left embankment and the left spillway training wall. Additional deterioration could destabilize those portions of the dam.

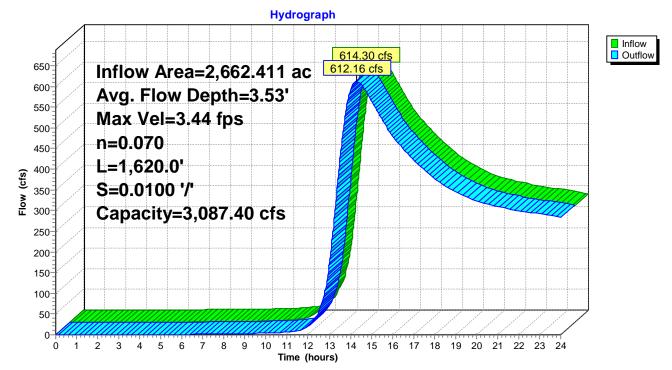
Reach 16R: K.B.R. to Waite Pond

$\begin{array}{rcl} \mbox{Inflow Area} &=& 2,662.411 \mbox{ ac}, & 9.87\% \mbox{ Impervious, Inflow Depth} > & 1.66" & for 100-year event \\ \mbox{Inflow} &=& 614.30 \mbox{ cfs } @ & 14.06 \mbox{ hrs, Volume} & 367.453 \mbox{ af} \\ \mbox{Outflow} &=& 612.16 \mbox{ cfs } @ & 14.30 \mbox{ hrs, Volume} & 360.683 \mbox{ af, Atten} = 0\%, \mbox{ Lag} = 14.5 \mbox{ min} \\ \end{array}$

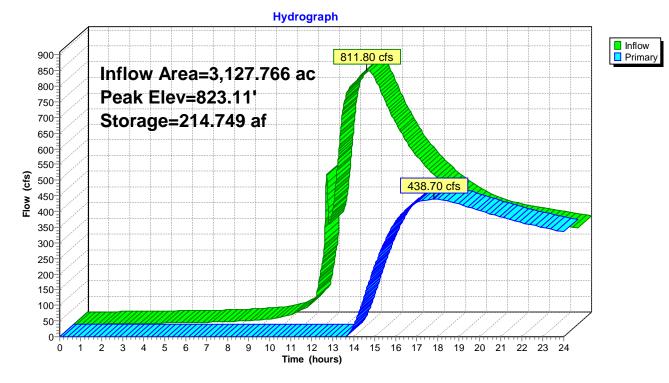
Pond 3P: Waite Pond

-2=Right Embankment Crest (Controls 0.00 cfs)

-3=Left Embankment Crest (Controls 0.00 cfs)
