Notice of Intent and Application for Permit Waite Pond Dam Repairs

Leicester, Massachusetts

Town of Leicester

November 1, 2017

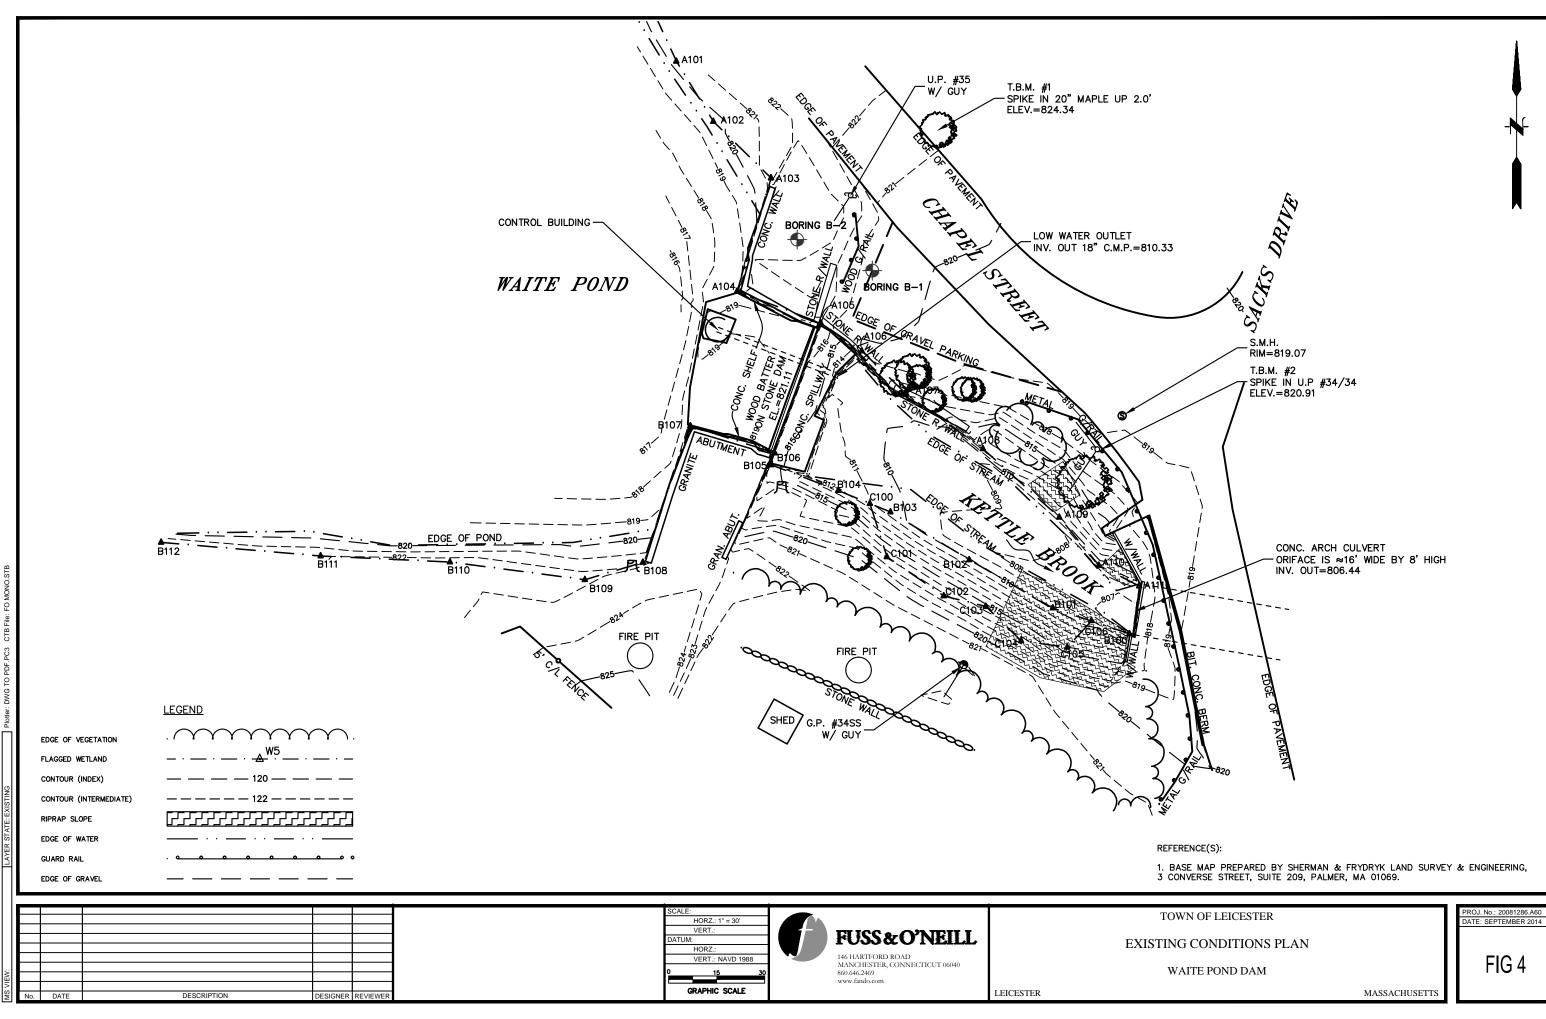
DATE: OEI TEMDER 2014
FIG 4

The upstream face of the dam is supported by concrete retaining walls. The downstream right face of the dam consists of a vertical dry-laid masonry wall. The downstream left embankment consists of a relatively flat earthen area used for parking, supported along the stream by a vertical masonry wall that has partially collapsed. The left dam crest is isolated from the parking area by a timber post and rail fence. An existing conditions plan is provided as *Figure 4*.

The bedrock cores advanced in boring B-1 used an NQ core barrel with water-cooled diamond bit. The resulting core (2.16-inch diameter) was measured to determine the Rock Quality Designation (RQD), a measure of the relative amount of fracturing and general quality of the rock. The locations are indicated on *Figure 4*, labeled borings B-1 and B-2.

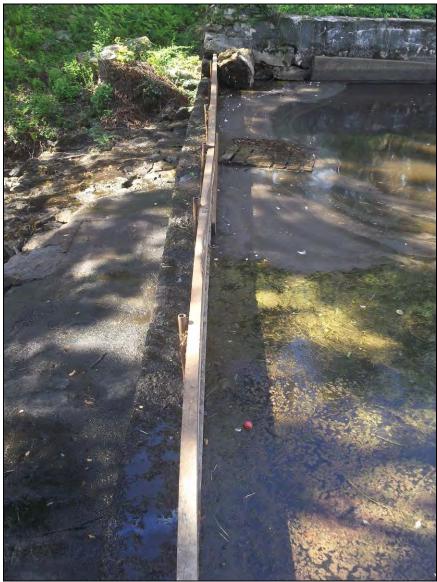
is breaking into fragments but seems to be functioning satisfactorily. (See Photo 14) Weir boards were in place during our inspection and appeared to be in satisfactory condition, with minor leakage through the boards. (See Photo 13)

Photo 13: Overview of weir

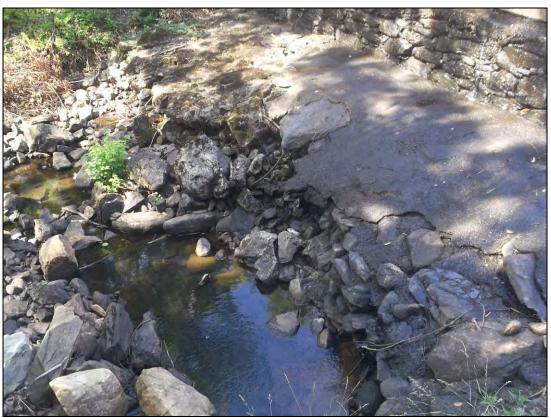
Photo 14: Overview of stilling basin

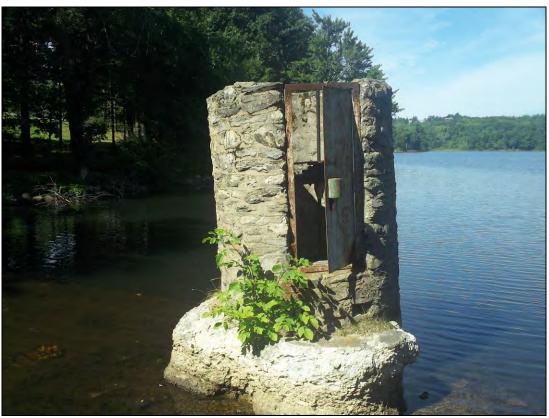
The 24-inch CMP low level outlet was rusted and appeared to be approximately $\frac{1}{2}$ full of sediment, but was flowing (See Photo 18). The operator is located in a circular structure in the impoundment. There is currently no access to the structure except by wading or boat. There is no roof on the structure, which is leaning over (See Photo 16). The concrete foundation is severely eroded. It is not known if the gate operator is functional.

Photo 16: Overview of gatehouse exterior
